March 29, 2013
File No. 18.0171599.00

Re: Condition Assessment Report Letter
Salisbury Beach Emergency Work
Salisbury Beach State Reservation
Salisbury, MA

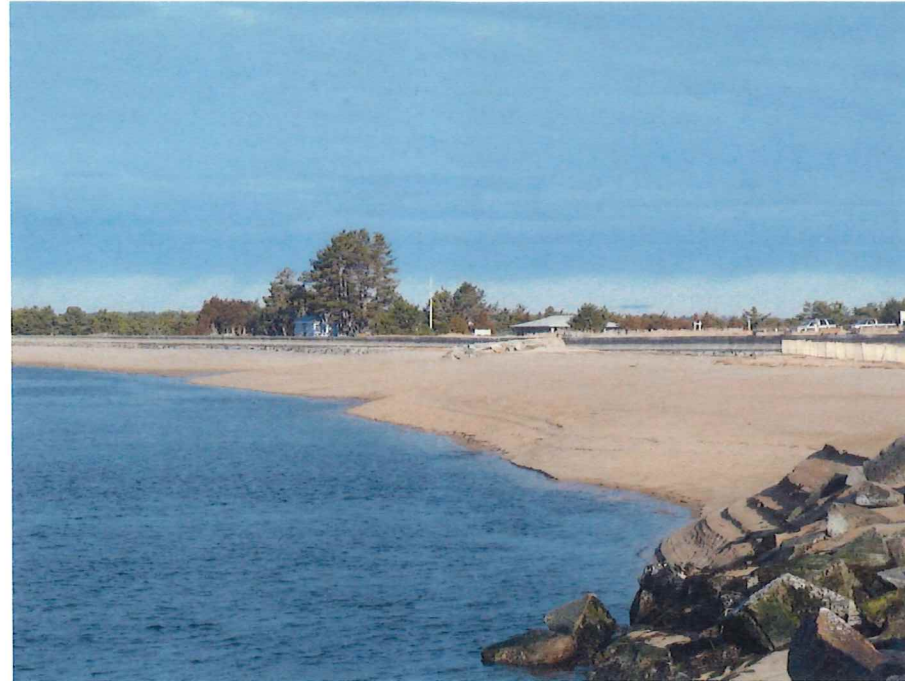
PHOTOGRAPH 1
Sand Shoal area

Due to the recent storm events, a sand shoal area has formed at the southern end of the Salisbury Beach State Reservation between the east parking lot and the Merrimack River where the North Jetty intersects with the beach (see Photograph No. 1). Additional topographic and hydrographic survey work was performed in this location to better define the limits of the shoaling.

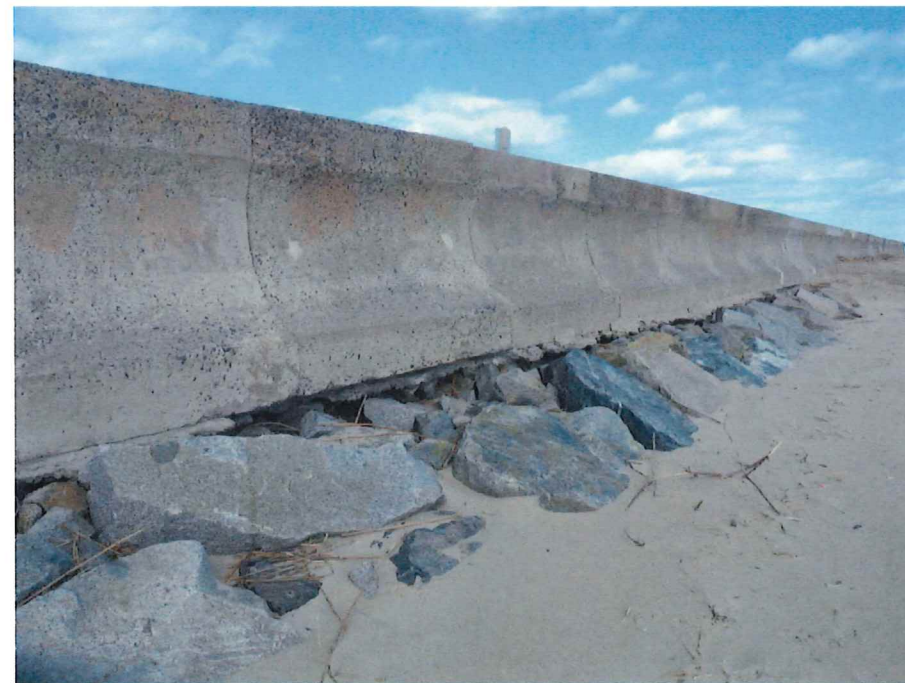
A visual inspection of the wall was performed on March 23, 2013. For the 2,062 lineal feet of seawall, it was observed that there was approximately 1,100 lineal feet of exposed concrete seawall leveling slab/stone mound. Of the approximate 1,100 lineal feet, approximately 600 lineal feet of the top of stone mound was observed to have voids between the stones and concrete wall base (see Photographs 2 and 3). Several voids were approximately 18 inches high by over 3 foot deep. Landside sinkholes were observed within these void locations and landside of the wall joints (see Photograph 4). In addition, several concrete seawall sections were observed to have spalled and deteriorated concrete.

PHOTOGRAPH 2
Typical photograph of concrete seawall and stone mound
(Note: voids between stone mound and concrete leveling course)

Based on the visible inspection of the seawall and the riverside and landside conditions, we do not feel that sand filling along the wall will be required at this time. While sand filling of the sinkholes and voids could be performed, we feel sand filling on the river side, due to exposure and beach slope would erode. It is our opinion that more extensive structural improvements, such as resetting of the stones, concrete filling and installation of sand and filter fabric on the landside, would more appropriately address the existing conditions of the seawall.

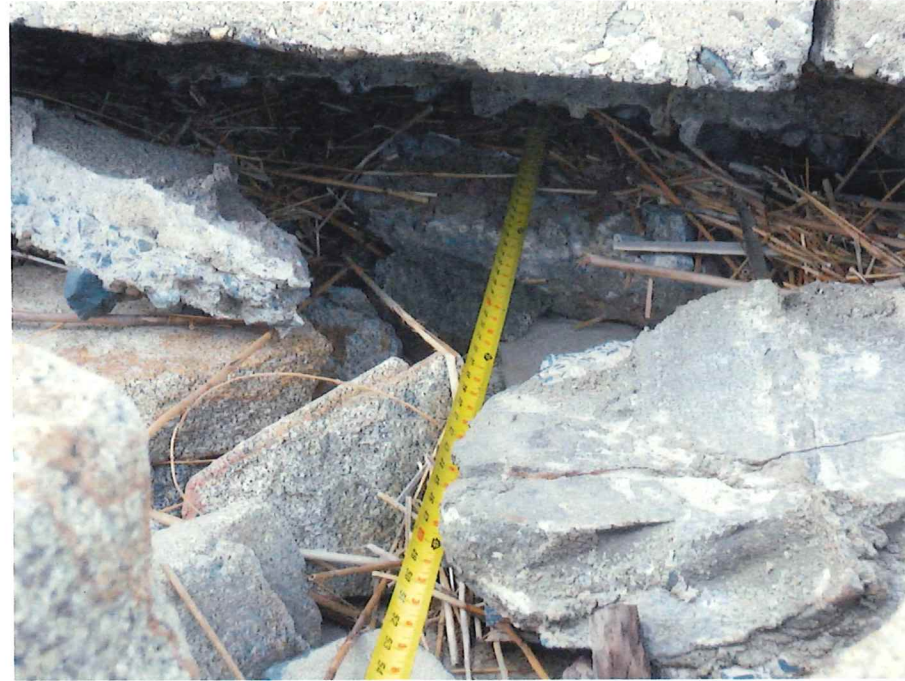
PHOTOGRAPH 3
Void between concrete seawall and stone mound.

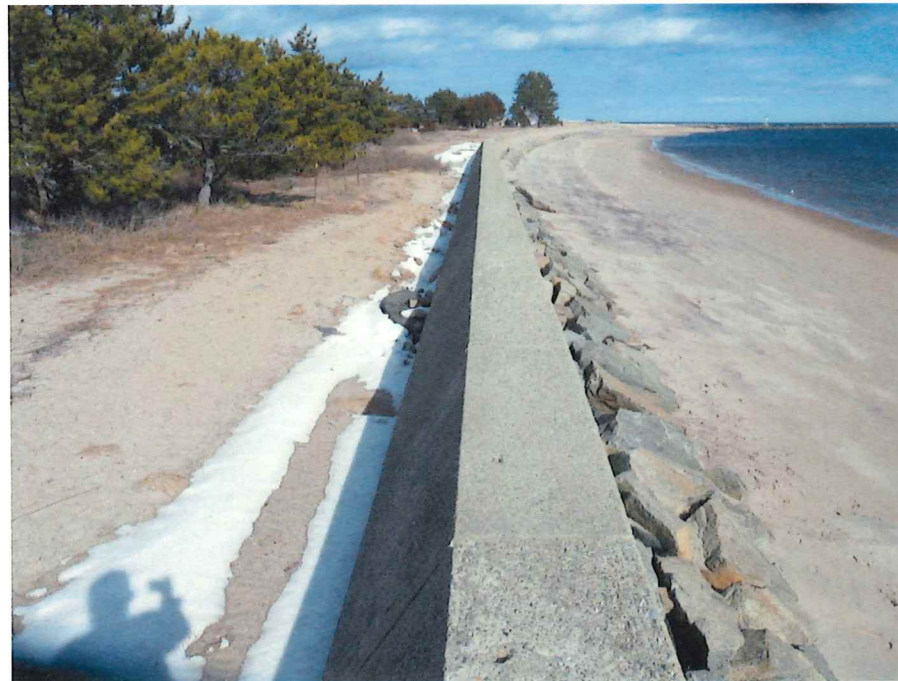
PHOTOGRAPH 4
Sinkholes along landside of seawall.

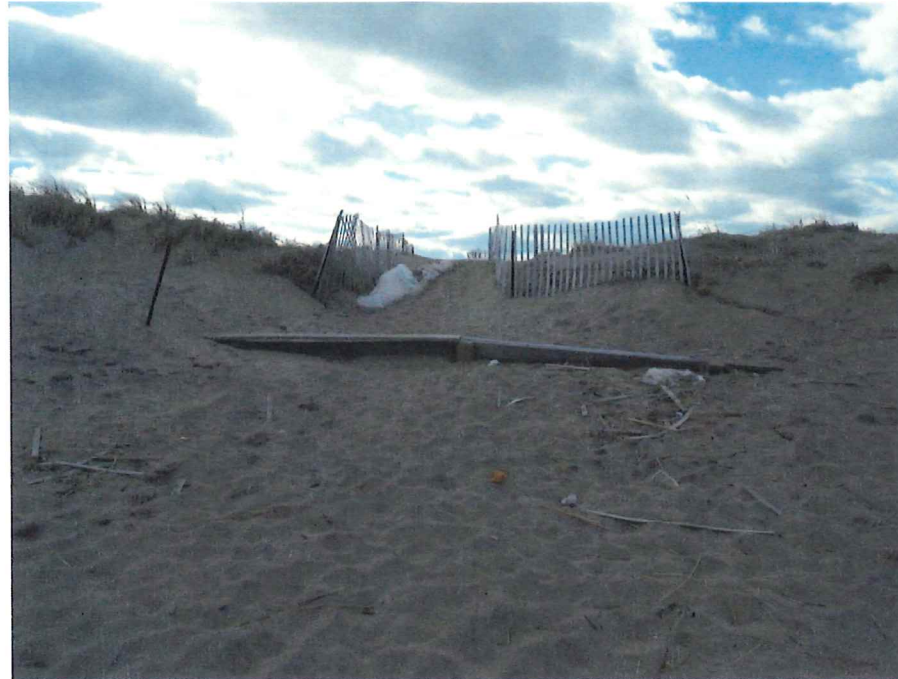
PHOTOGRAPH 5
Reservation Access No. 1

Reservation Access No. 1 is comprised of an elevated timber walkway structure with a ramp and stair structure providing access to the beach. At the time of survey and inspection, the stair was buried and the top of the ramp railing was exposed (see Photograph 5). We have considered the need for additional sand for improvement in this area to cover the existing exposed structure.

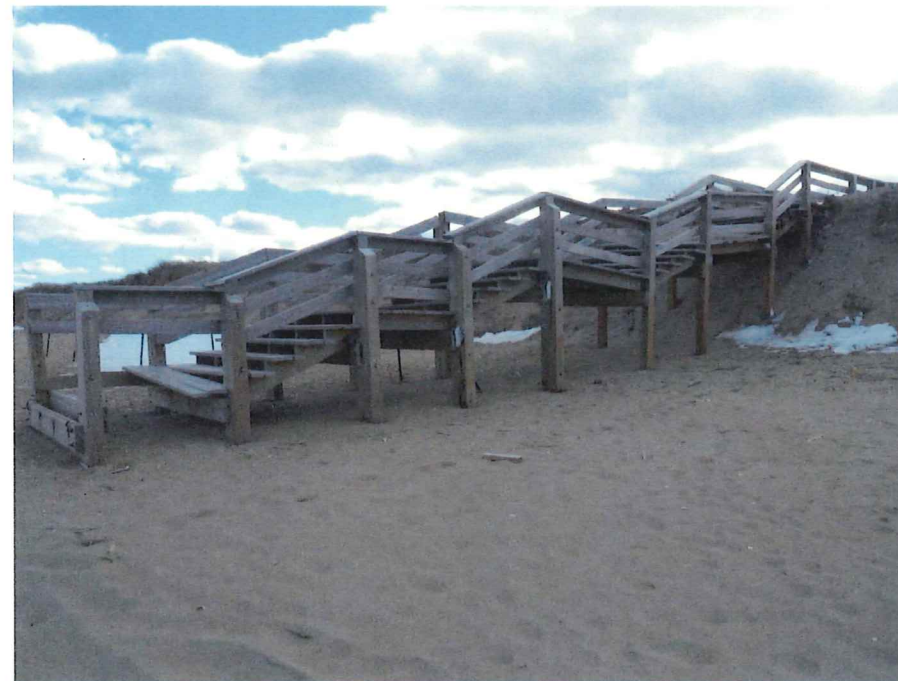
PHOTOGRAPH 6
Reservation Access No. 2

Reservation Access No 2 is a timber stair structure that is severely deteriorated and damaged (see Photograph 6). We have not considered sand improvement for this location.

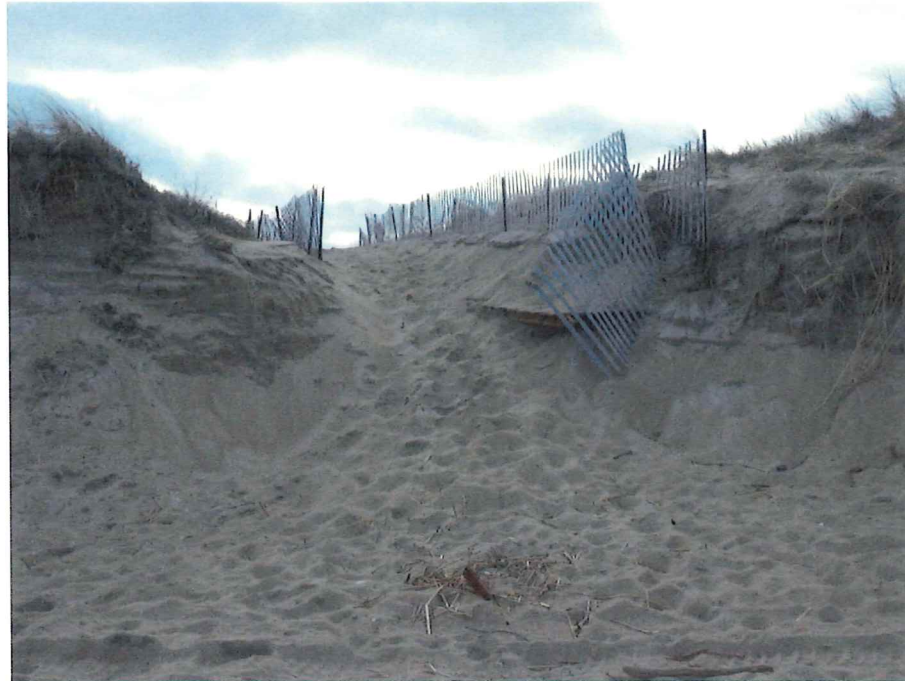
PHOTOGRAPH 7
Reservation Access No. 3

Reservation Access No.'s 3 and 4 are elevated timber walkway structures with a ramp and stair structures providing access to the beach. Both of these structures are buried below the existing sand. Portions of the structures are visible adjacent to the existing access path. The slope at each location is steeper than the recommended 1V to 5H slope and we have therefore considered the need for additional sand for improvement in these locations to flatten the slope to the beach.

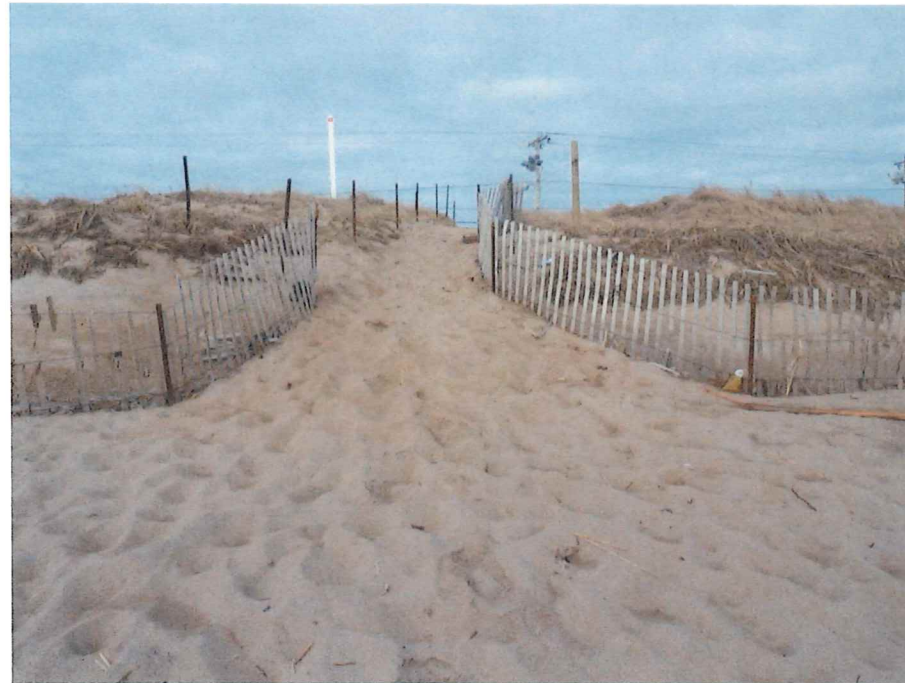
PHOTOGRAPH 9
Salisbury Beach Public Access No. 1 (Atlantic Ave)

- Public Access No. 1 (Atlantic Ave) – (see Photograph 9)
- Public Access No. 3 (Fowler Street) – (see Photograph 11)
- Public Access No. 6 (176 North End Blvd) – (see Photograph 23)
- Public Access No. 7 (Sullivan Way) – under construction
- Public Access No. 8 (14th St E) – (see Photograph 24) - closed due to stairway structural issues
- Public Access No. 9 (Sea Crest, 13th St) – (see Photograph 25)
- Public Access No. 10 (9th St. E) – (see Photograph 26)
- Public Access No. 11 (7th St E) – (see Photograph 27)
- Public Access No. 12 (Brookline Street) – (see Photograph 28)
- Public Access No. 13 (Beacon Street) – (see Photograph 29)
- Public Access No. 14 (Bay State Rd.) – (see Photograph 30)

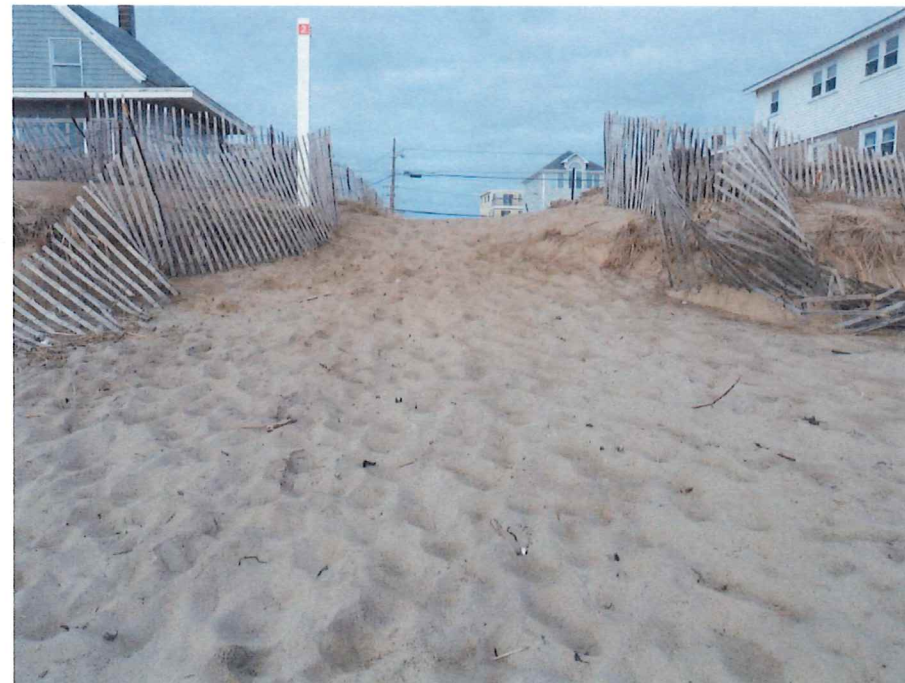
PHOTOGRAPH 10
Salisbury Beach Public Access No. 2 (Murray Street)

Public Access No.'s 2, 4 and 5 require sand improvements to create an access slope condition that is at least 1V to 5H. We have calculated sand to be placed in these locations at a 1V to 5H grade to provide safe access to the beach.

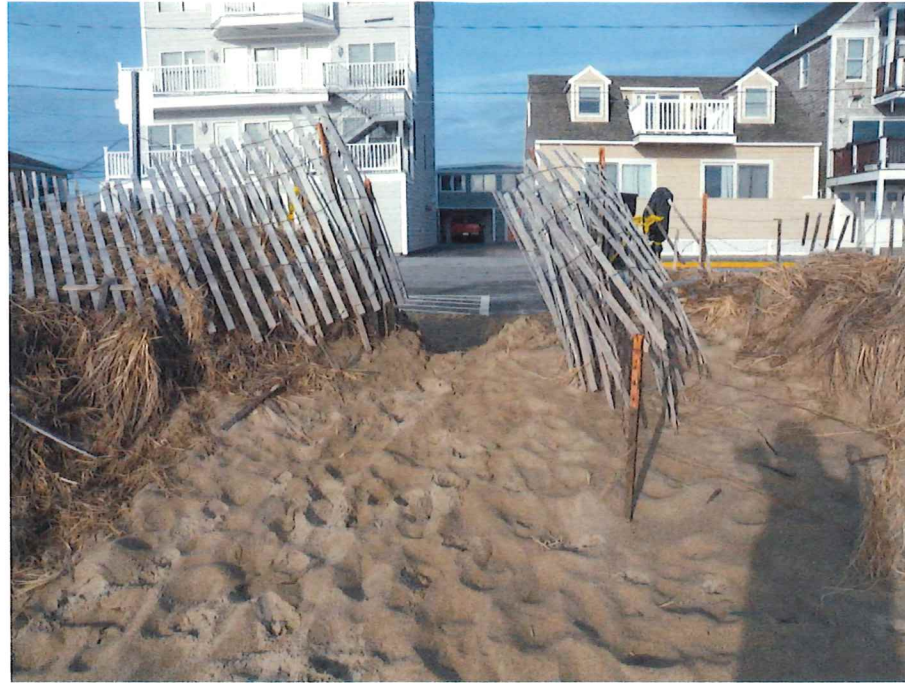
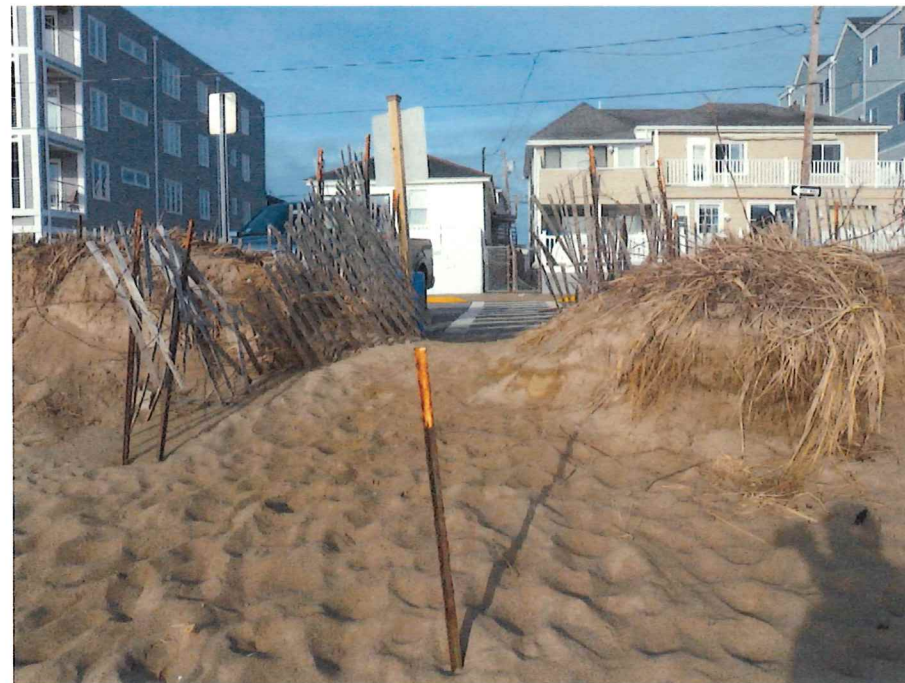
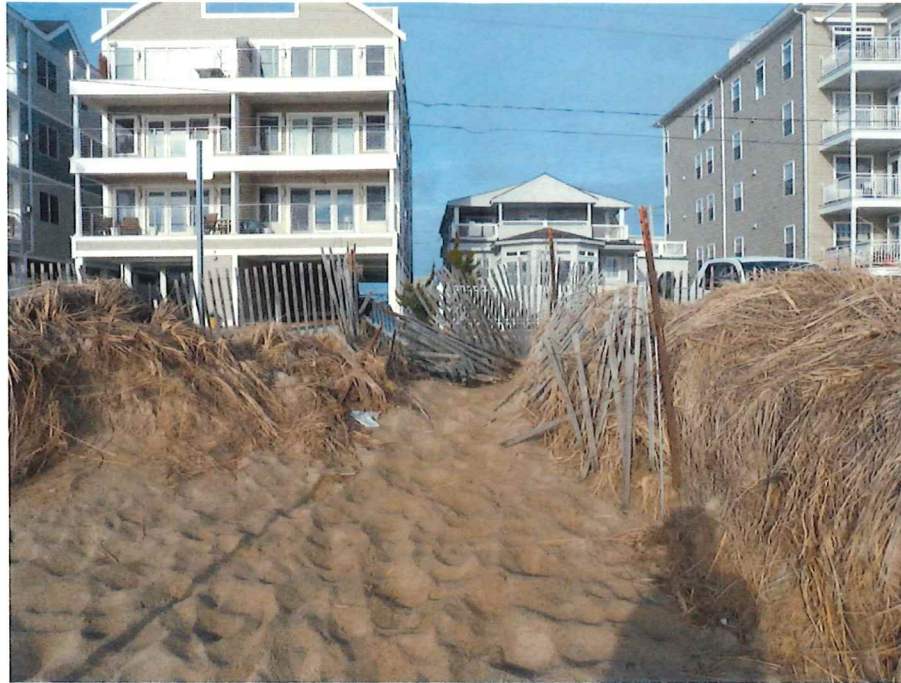
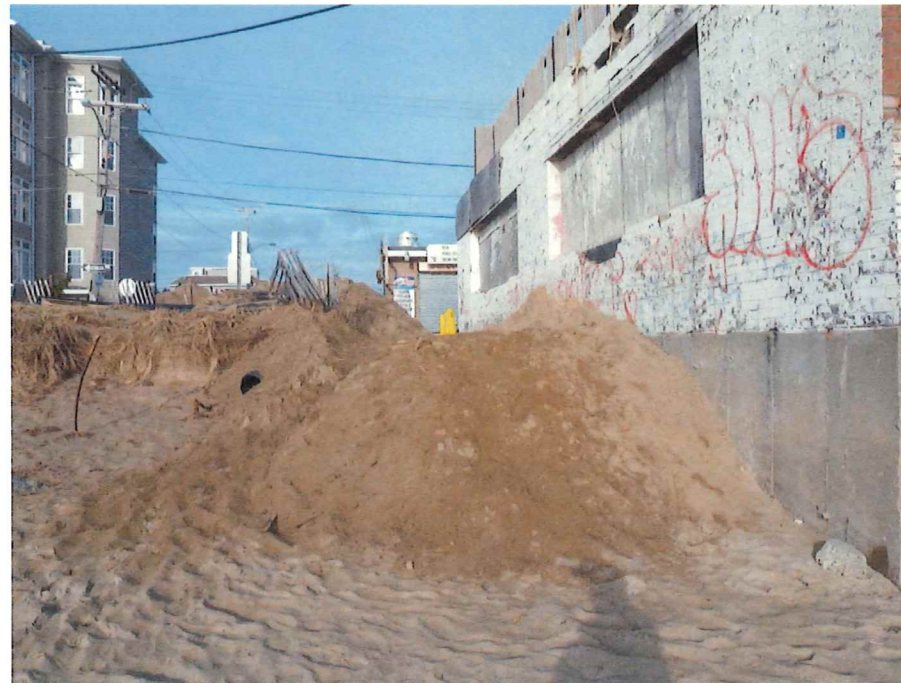
The four access locations along Ocean Front South are openings created to access the beach over the existing dune. Based on our survey and inspection, we feel Access locations 1 through 3 do not require sand improvement for safe access, however debris and snow fencing removal is required on Access No. 3 (see Photographs 13 through 15). Access No. 4 is located on the south side of the existing abandoned building, opposite Ocean Avenue and has a large pile of stockpiled sand. It is approximately 25 feet long, 14 feet wide and approximately 5 feet high along the edge of the roadway. It appears sand has been deposited and regraded along the access way to the beach (see Photograph 16). Due to a large volume of adjacent stockpiled sand and the unfinished regrading, we recommend further regrading work to be performed, without the need for sand import at this location.

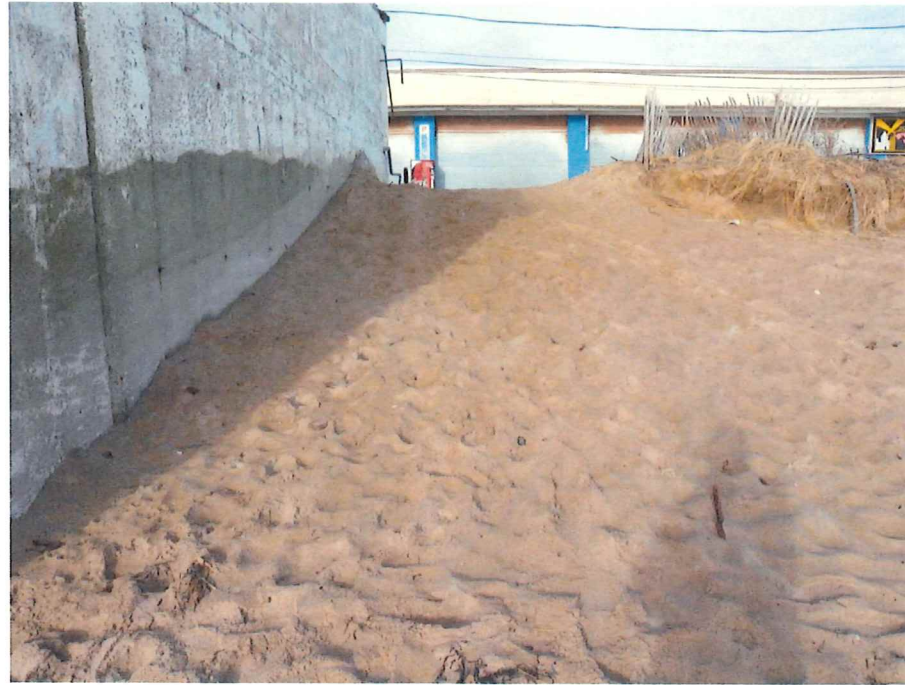
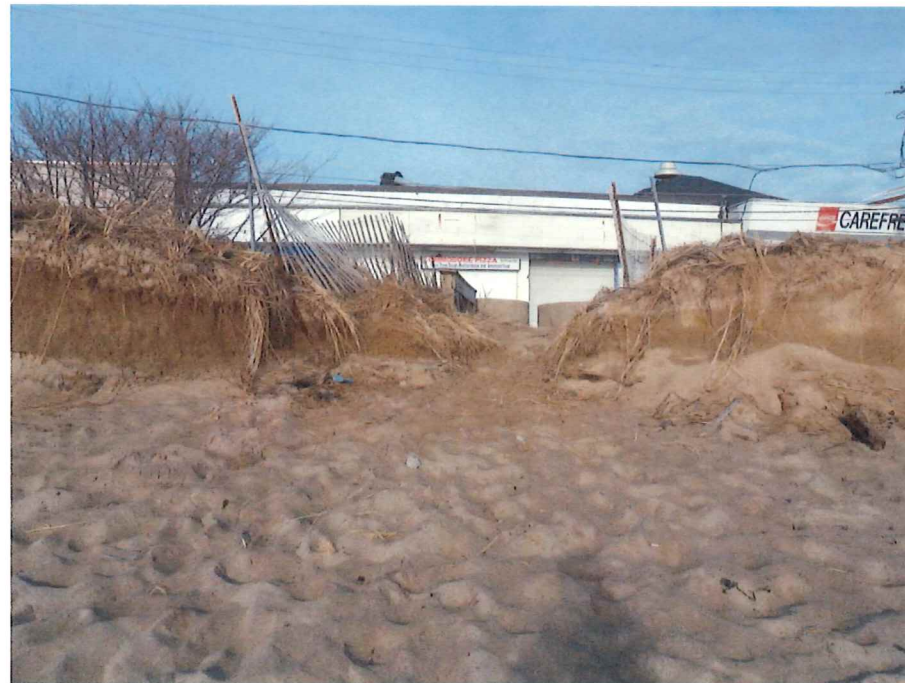
The three access locations off of Ocean Front North are openings created to access the beach over the existing dune. Access No. 1 in this area is located along the north side of the existing abandoned building. Based on survey and inspection, we feel sand improvement is required for the Access No.'s 2 and 3 locations. Both areas have an

eroded slope with a drop of over 3 feet in elevation. We have calculated sand to be placed in these locations at a 1V to 5H grade to provide safe access to the beach.

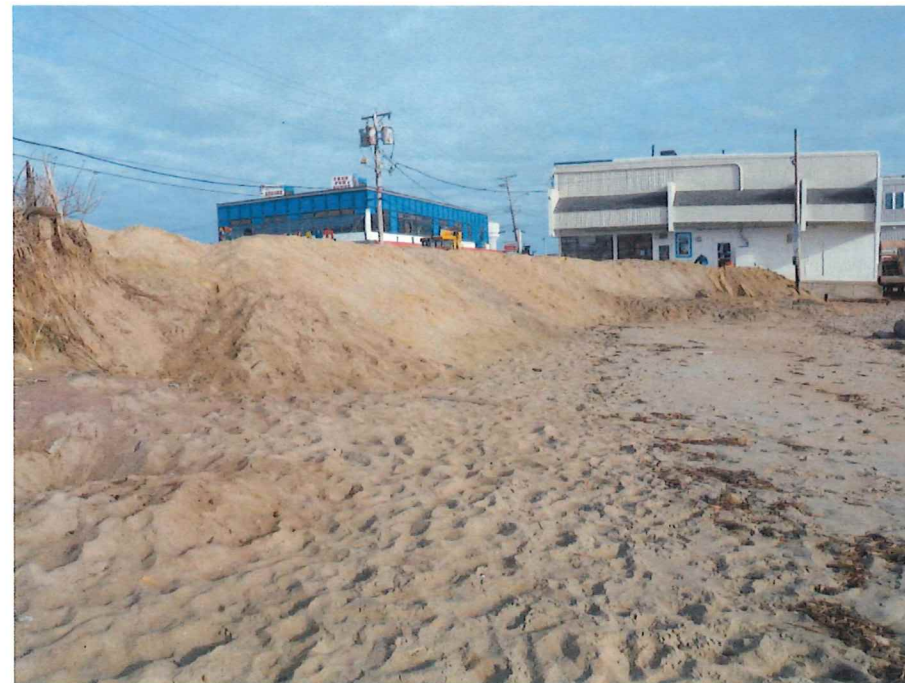
PHOTOGRAPH 20
Beach Center No. 1 (south of Surfside 5).

Beach Center Access No. 1 in this area is from the northern end of Ocean Front North to the south side of the Surfside 5 Restaurant. This area was observed to have a stockpile of sand placed seaward of the jersey barriers along the edge of the roadway (see Photograph 20). For volume calculations we considered the top of the existing stockpiled sand would be regraded to equal the roadway elevation and the sand would be redistributed along the beach. Additional volume of sand would be required to maintain a 1V to 5H slope for access.

We have calculated additional sand to be placed at Beach Center No.'s 1 and 2 under the Priority 2 category. Additional sand would be placed at a 1V to 10H slope to provide improved public access in these locations.

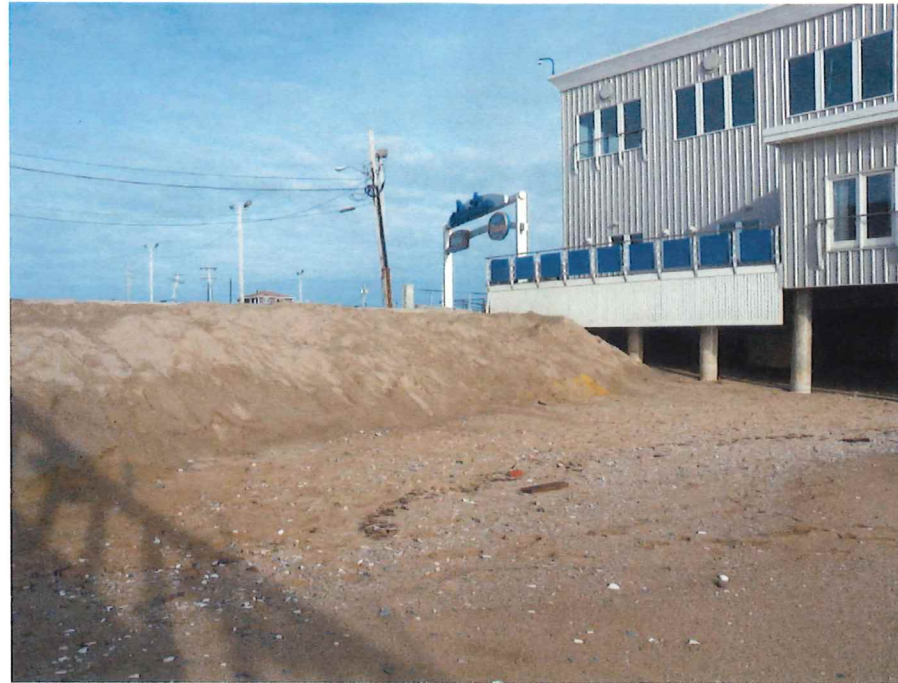
Beach Center Access No 2 is the area between the Surfside 5 Restaurant and the Seaglass Restaurant. This area was observed to have a stockpile of sand placed seaward of the jersey barriers along the edge of the roadway (see Photograph 21). For volume calculations we considered the top of the existing stockpiled sand would be regraded to equal the roadway elevation and the sand would be redistributed along the beach. Additional volume of sand would be required to maintain a 1V to 5H slope for access.

Beach Center No. 2 (between Surfside 5 and Seaglass Restaurants).

Information regarding the observed stockpiled sand is unknown. It should be further investigated prior for use in regrading work as to the ownership of the sand, the compatibility for use on the beach and its origin.

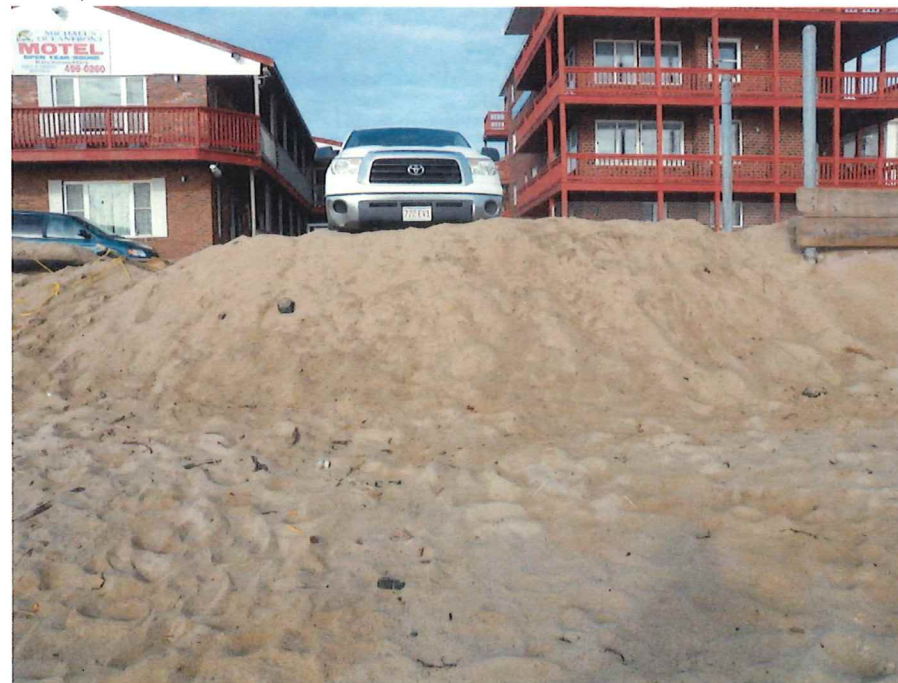
Salisbury Beach Public Access No. 5 (Central Ave.)

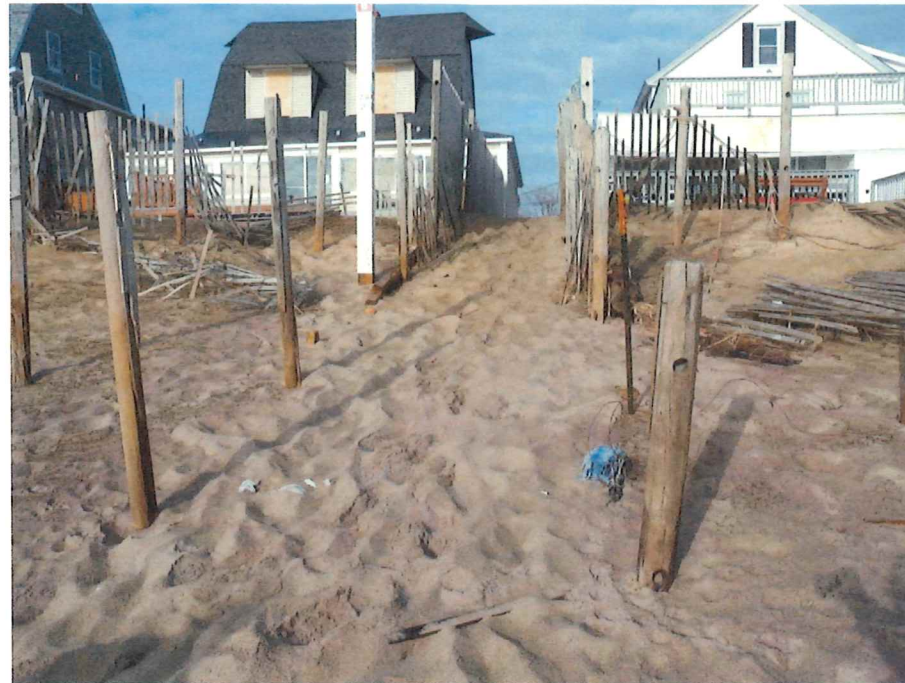
Salisbury Beach Public Access No. 6 (176 North End Blvd.)
(Note: Access No. 7 was under construction)

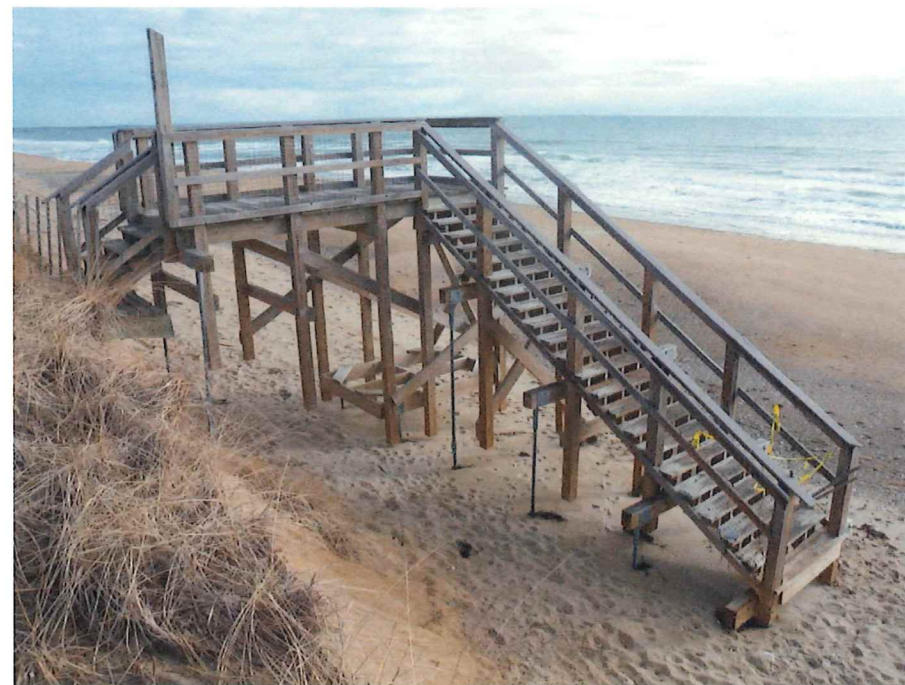
The length of beach area between Public Access No.'s 7 and 8 was included in the survey limits. The dune between the two access locations was observed to be eroded with the dune adjacent to Access No. 8 severely eroded, and the timber stairway was undermined, with the bottoms of the timber support posts exposed. Helical anchor supports appear to provide the major support for the stair structure. The timber stairway was closed for access due to the timber transitional walkway from the dune to the stair structure having failed (see Photograph 24). At the time of the inspection, Access No. 7 was being utilized by a contractor to haul in sand for dune repairs to several residences along the beach.

Salisbury Beach Public Access No. 8 (14th Street E.)

Based on our conversation, if additional sand is available from the sand shoal after redistribution to the access ways and the Beach Center, the excess would be placed between Public Access No.'s 7 and 8. Sand would be placed approximately 2 feet high above the bottom of the eroded dune and extend out onto the beach at a 1V to 10H slope.

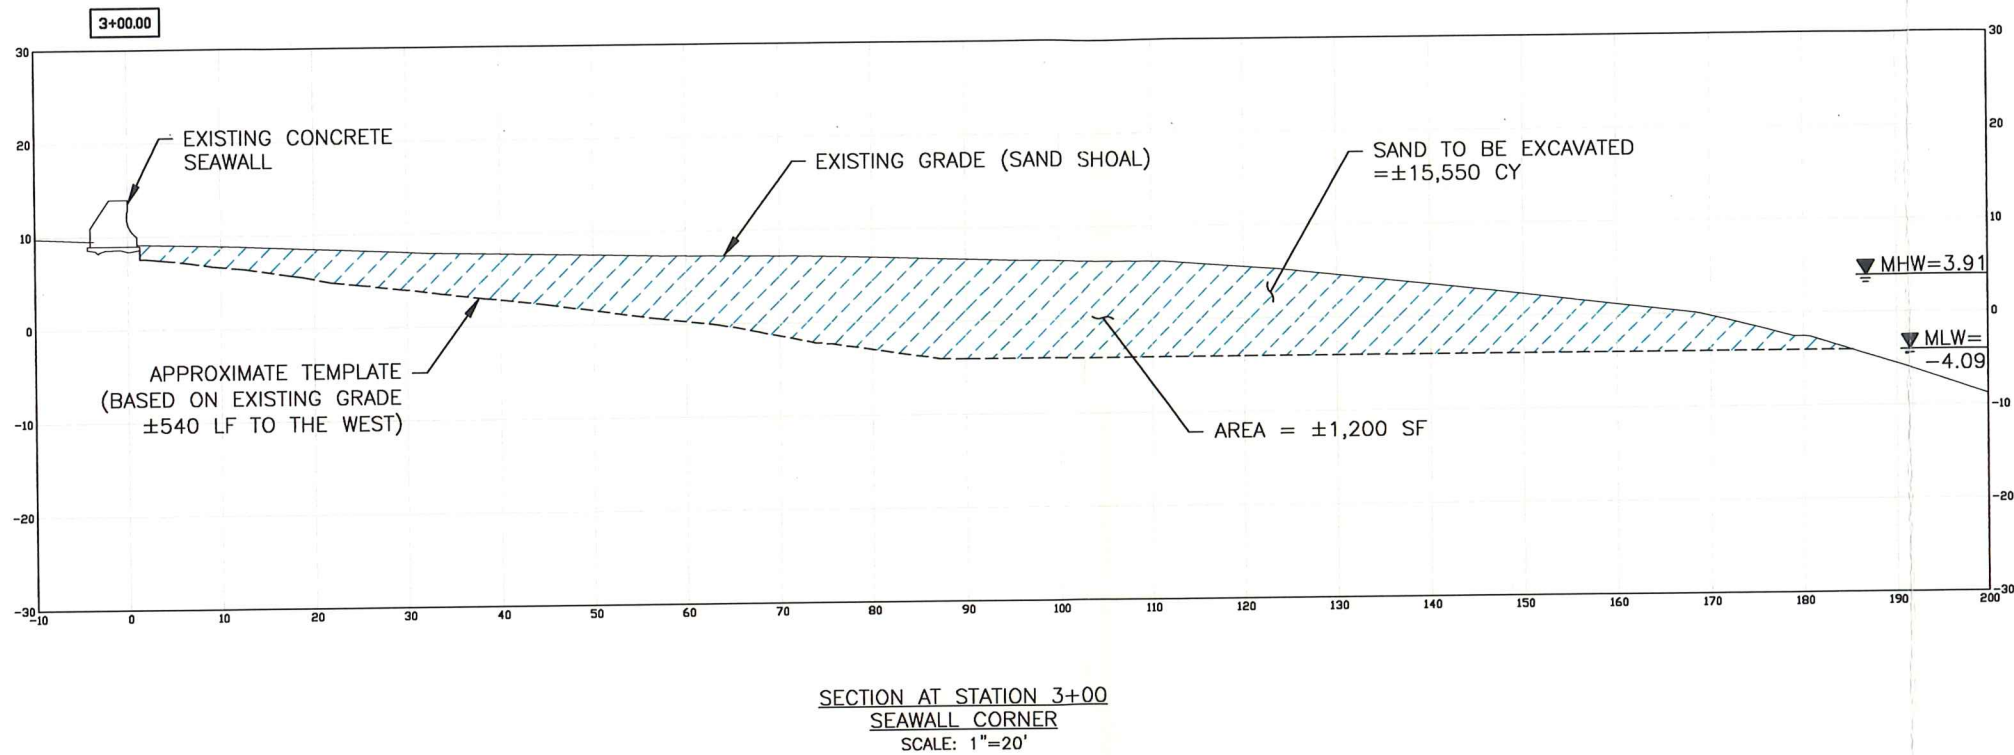
The estimate of the available sand was initially calculated by comparing two cross-sections; 1) at the eastern corner of the seawall (Station 3+00 as shown in Figure 3 in Attachment D), which represents a wider section through the sand shoal and 2) at a location approximately 540 feet west from the seawall corner at Station 3+00. This section represents a typical cross-

section of the seawall and beach area on the riverside, away from the sand shoal. We calculated the area between the two (assuming the typical wall/beach section until it intersects with the MLW elevation, and then extending it horizontally to the shoal section grade intersection). We multiplied the area by an assumed distance of 350 lineal feet. We calculated an initial volume of approximately 15,550 cubic yards. This approximate volume was conveyed to you by email and verbally on March 27, 2013. Based on several visits to the site over the past week and a half, we have noticed the sand shoal to be diminishing rapidly in size. Therefore utilization of the sand for beach improvements should be scheduled as soon as possible. Additional survey and volume calculations may be necessary for a more accurate determination on available sand, if necessary.

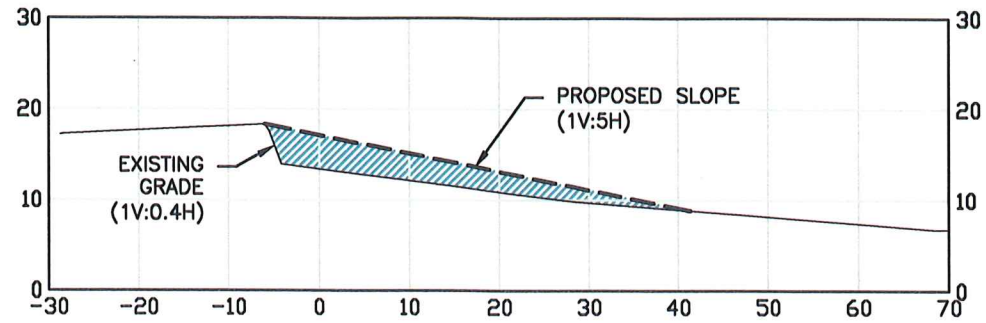
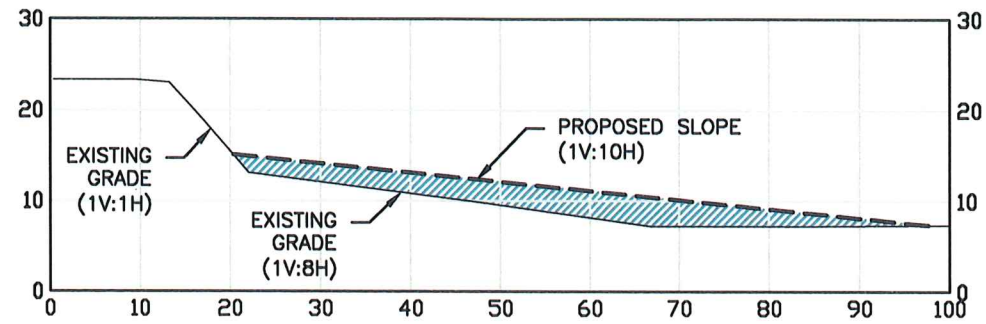
ADDITIONAL SAND PLACEMENT SECTIONS
 SCALE: 1"=20'

The Beach Center between Public Access No. 4 at Vermont Street northward approximately 1,500 lineal feet to the south side of the Seaglass Restaurant Building has experienced erosion of the existing dune outside of the access locations as referenced above. We have surveyed this area and have calculated a volume of sand to be placed along the dune length from the top of eroded dune seaward at a 1V to 5H slope. The sand to be placed in this location would be considered a Priority 2 category.
