# Beach Management Community Forum

The communities of Salisbury, Newbury, and Newburyport joined together on a long-term, regional planning effort to evaluate coastal erosion and sediment transport and the feasibility of shore protection strategies.

# Upper North Shore Regional Sediment Study

Sustainable Coastal Solutions

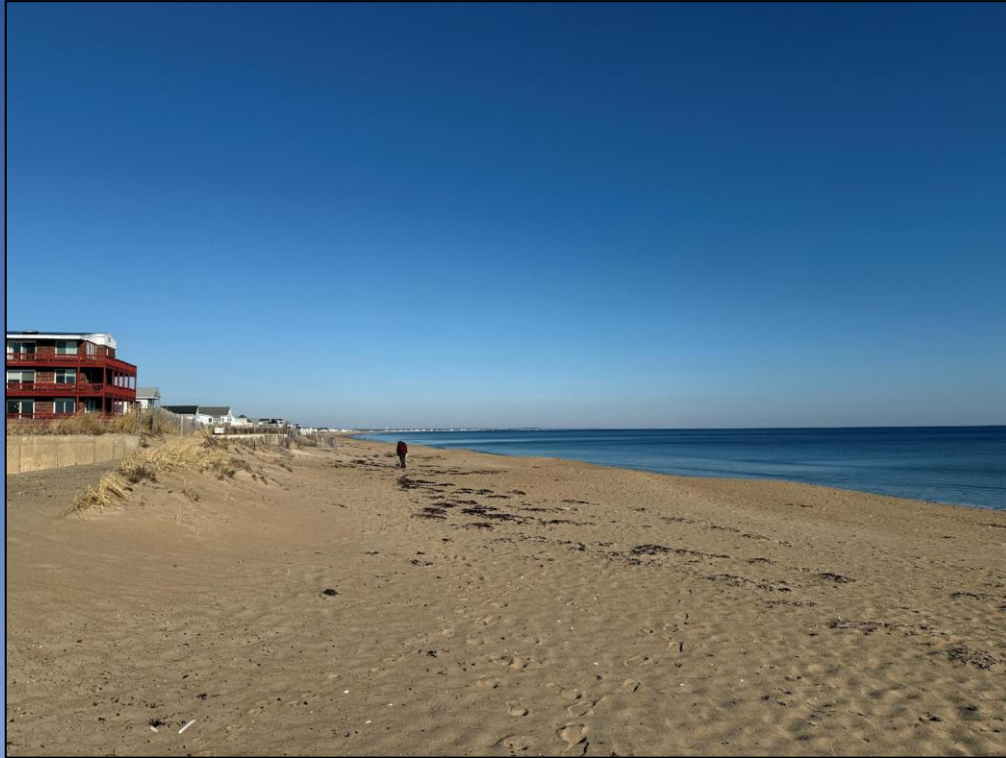
- Generally low beach and dune system
- Natural sediment movement constricted due to jetties to the north and south
- Sediment migrates offshore to bypass bar north of jetty

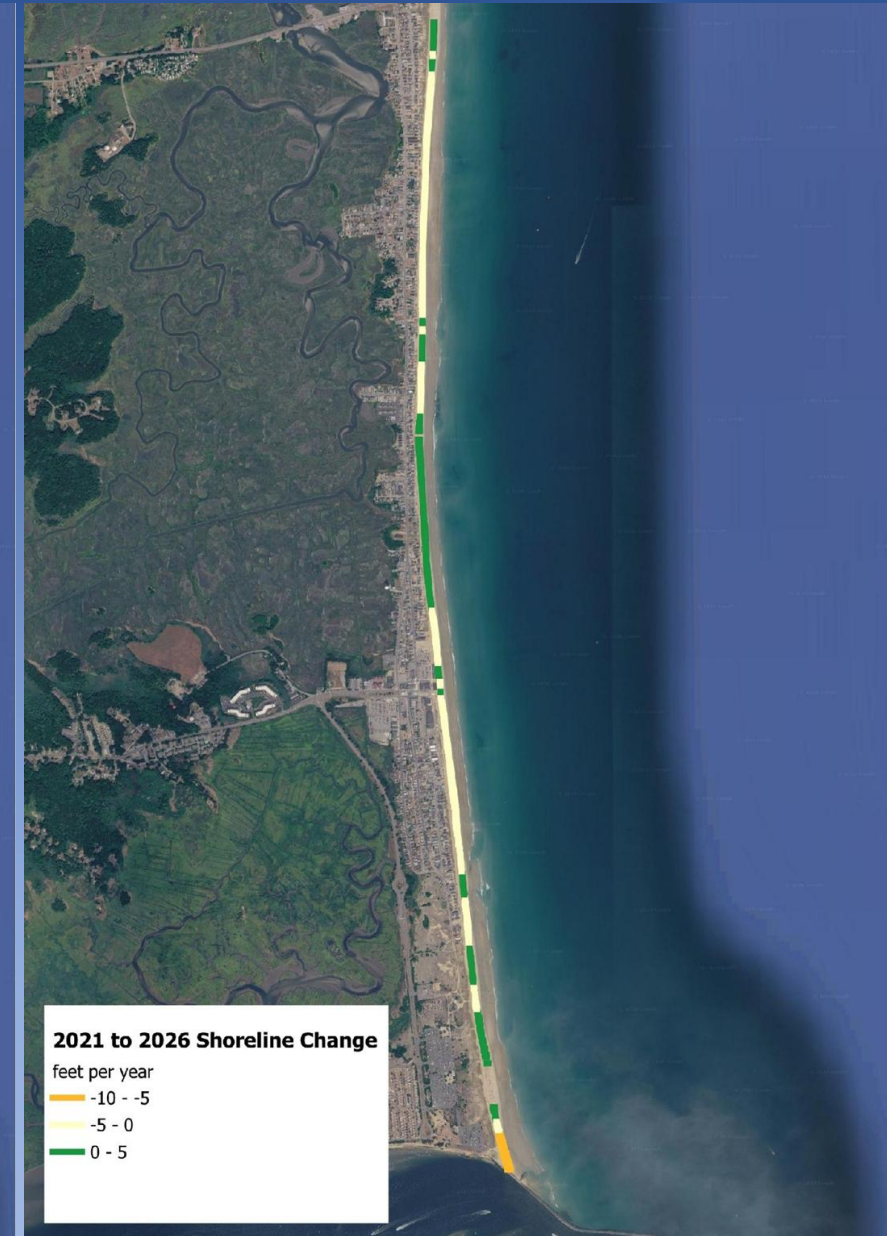
### Shoreline change

- 2014 to 2021: multiple significant storms, erosion
- 2021 to 2026: fewer significant storms, stable (minor erosion and accretion in some areas)

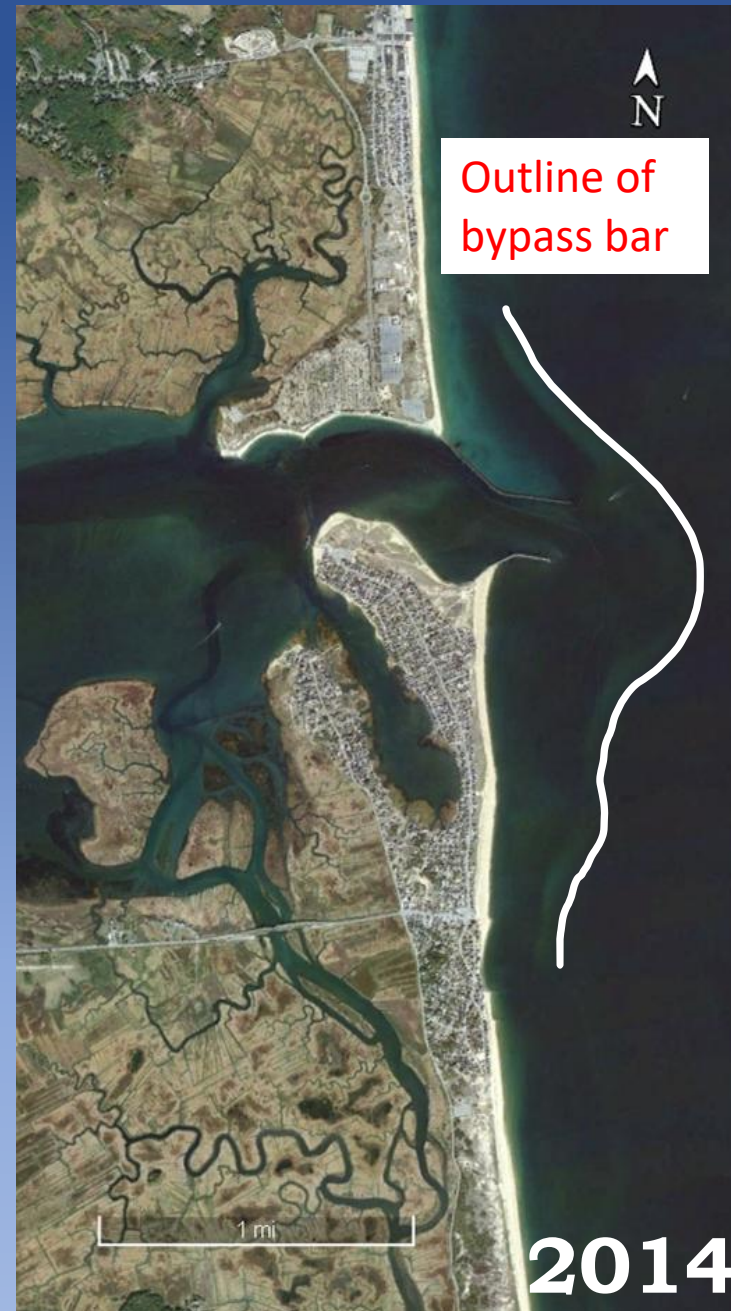
- Shelters Plum Island from waves
- Provides sediment source to Plum Island
- Refracts waves to drive northern transport
- Erosion hotspot changes based on bypass bar location

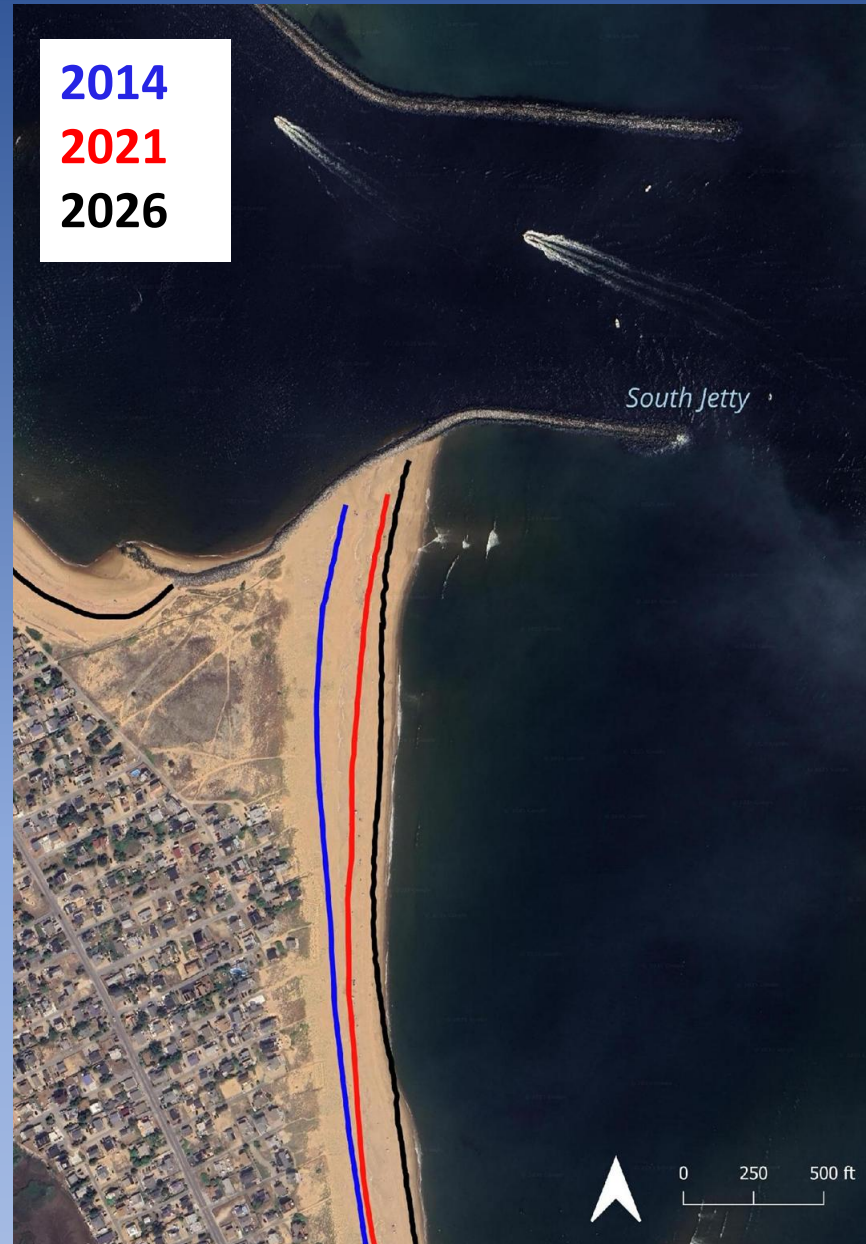
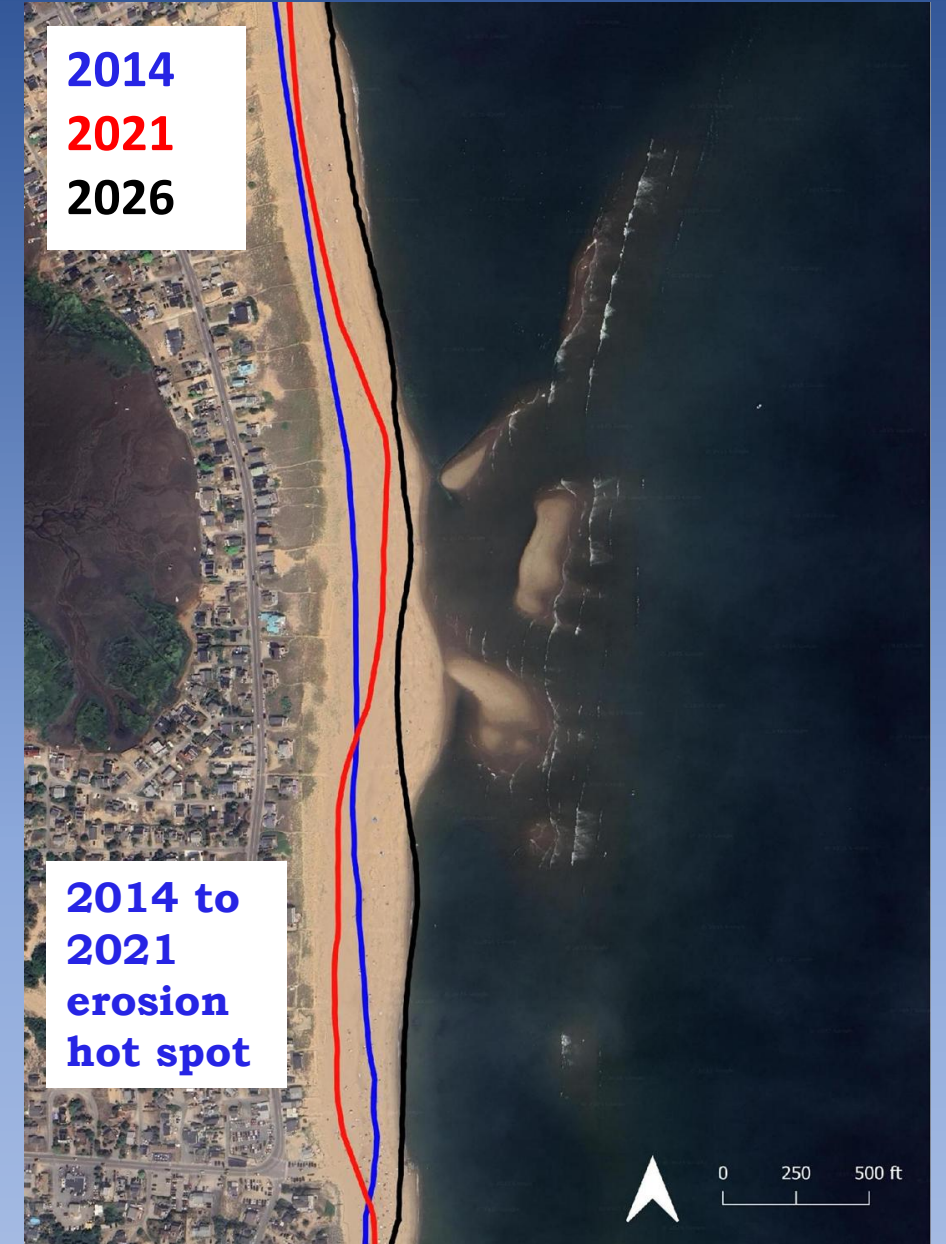
- Overall significant accretion since jetty reconstruction
- Erosion hotspot resolved between 2021 to 2026

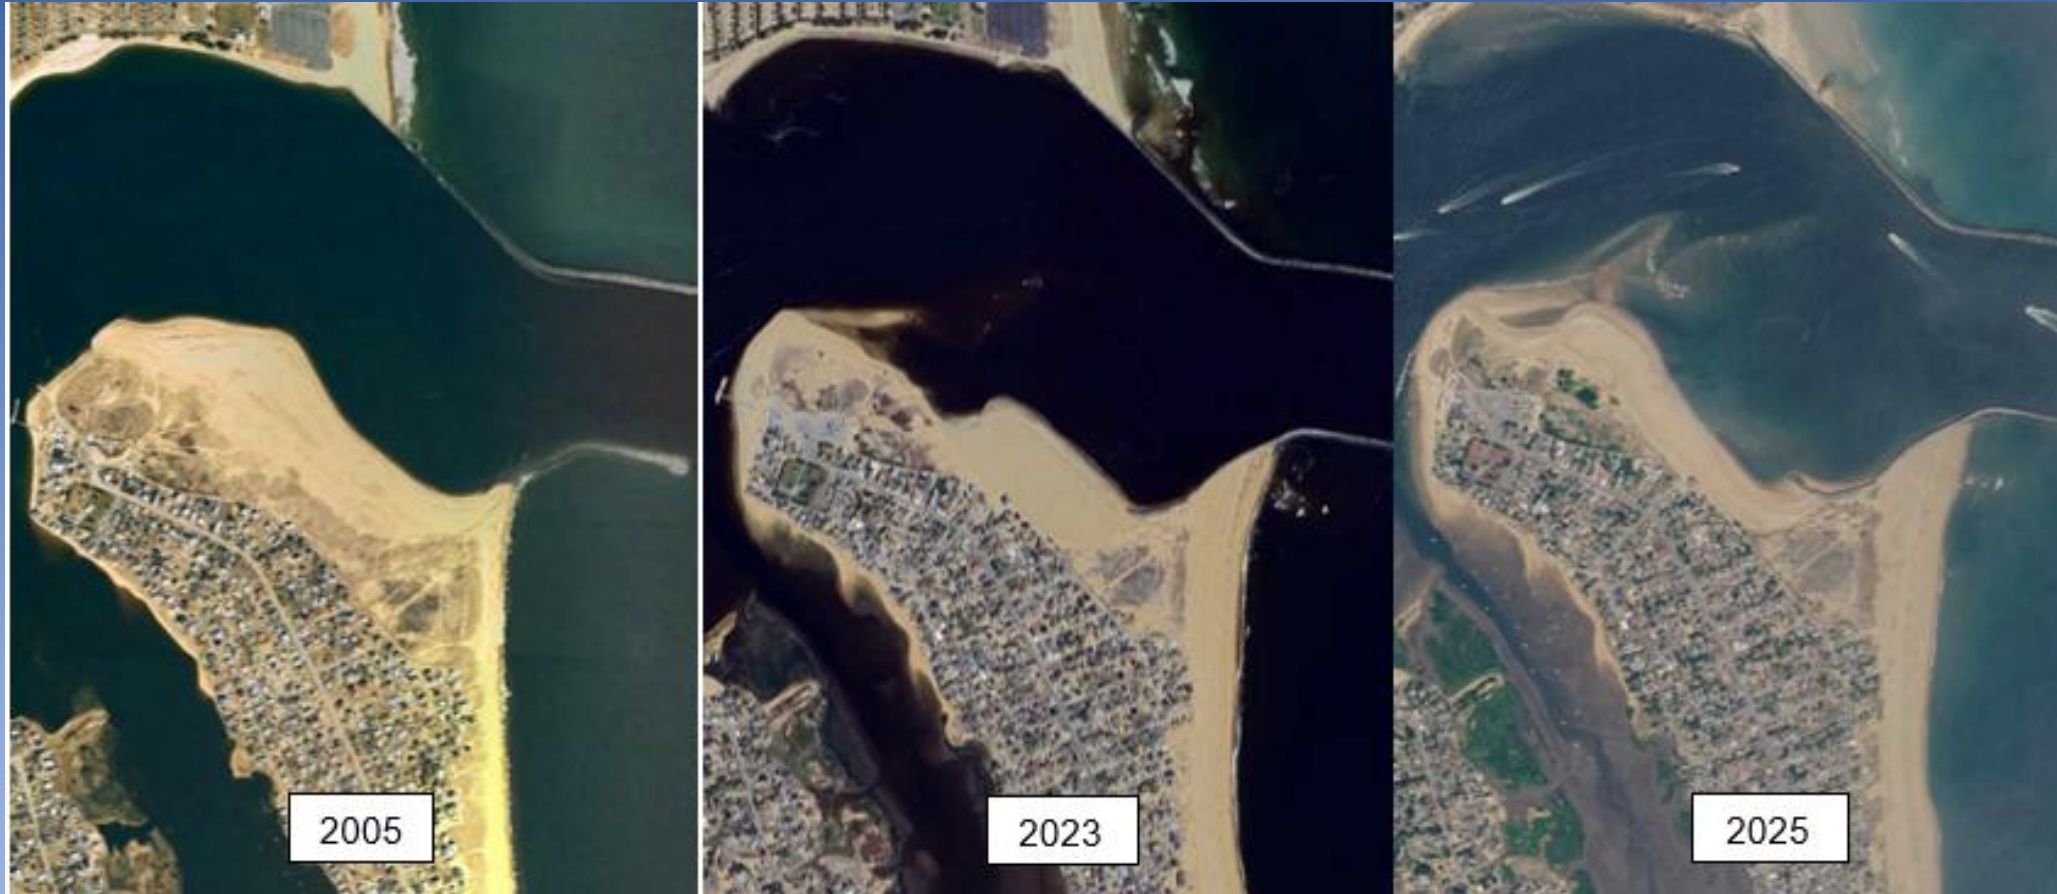
- Rapidly eroding shoreline
- Sediment starvation
- Inlet tidal circulation (see next slide)

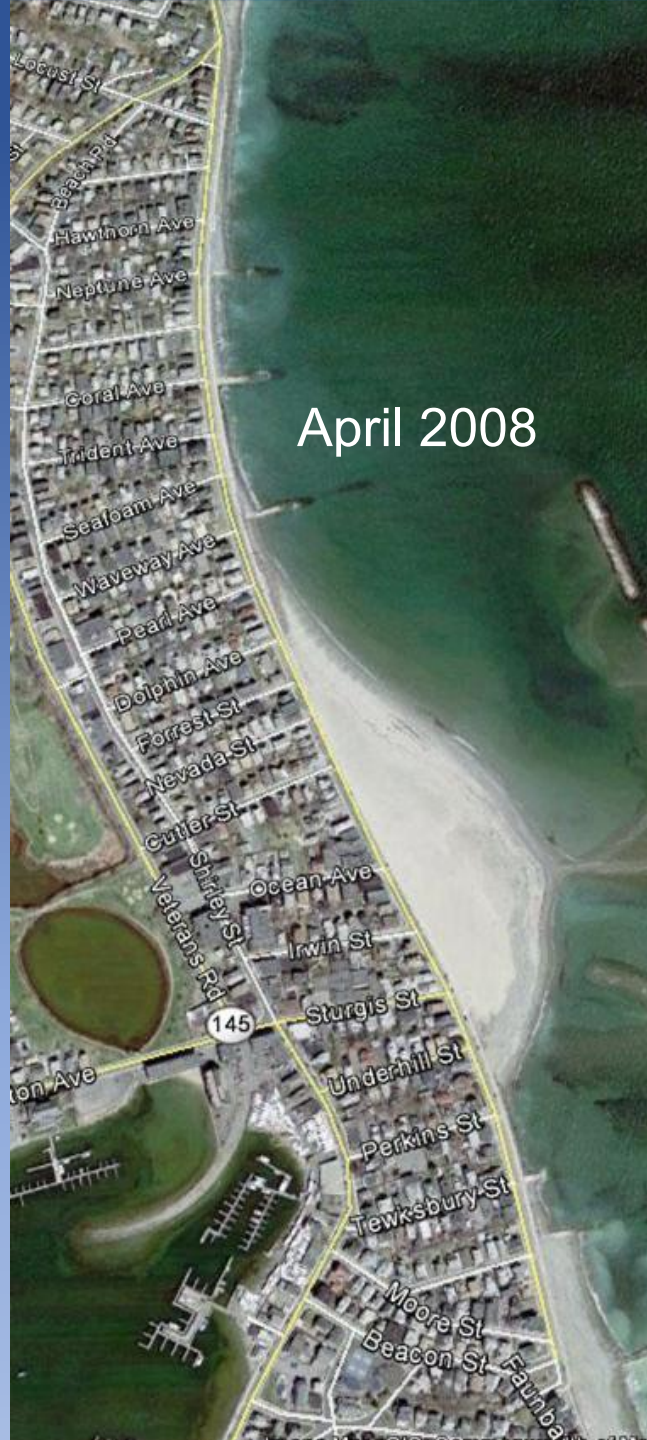
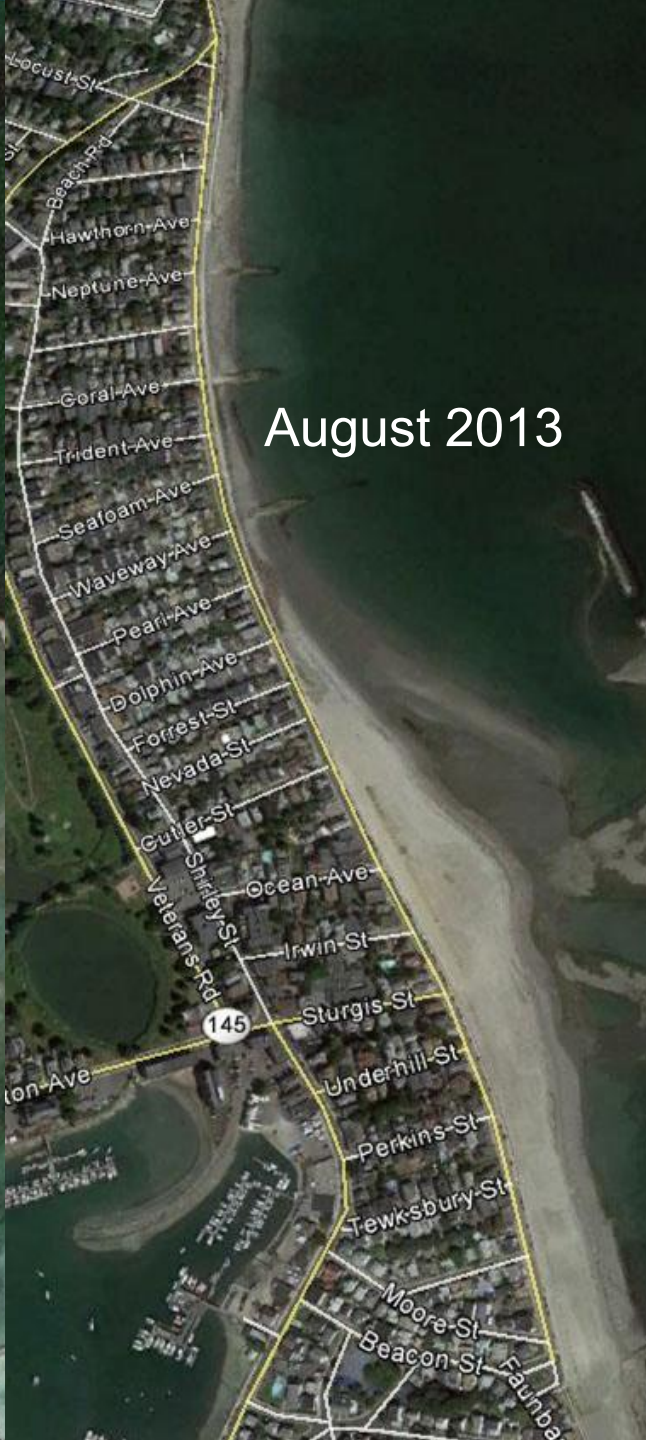
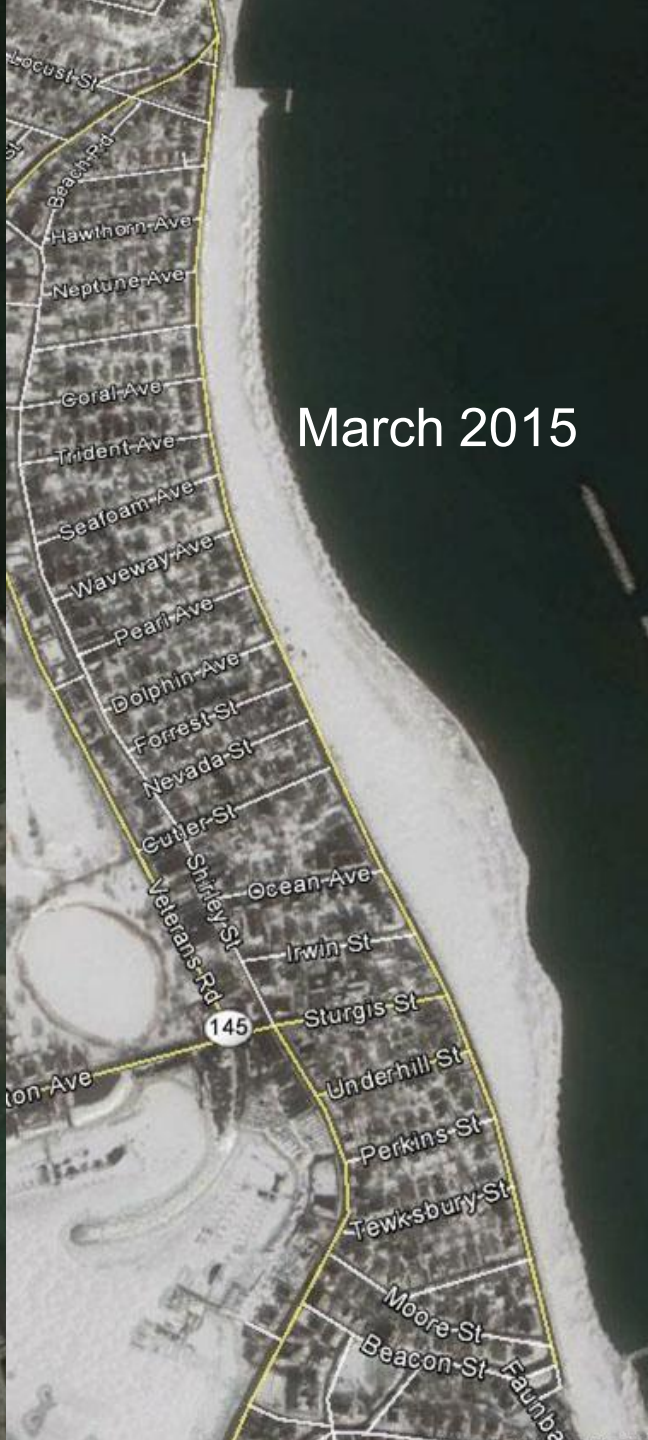
## Example of successful large-scale beach nourishment project Winthrop, MA

April 2008

August 2013

March 2015
