# Massachusetts Upper North Shore Regional Sediment Study

## Prepared for:

## Prepared by:

*Sustainable Coastal Solutions, Inc.*

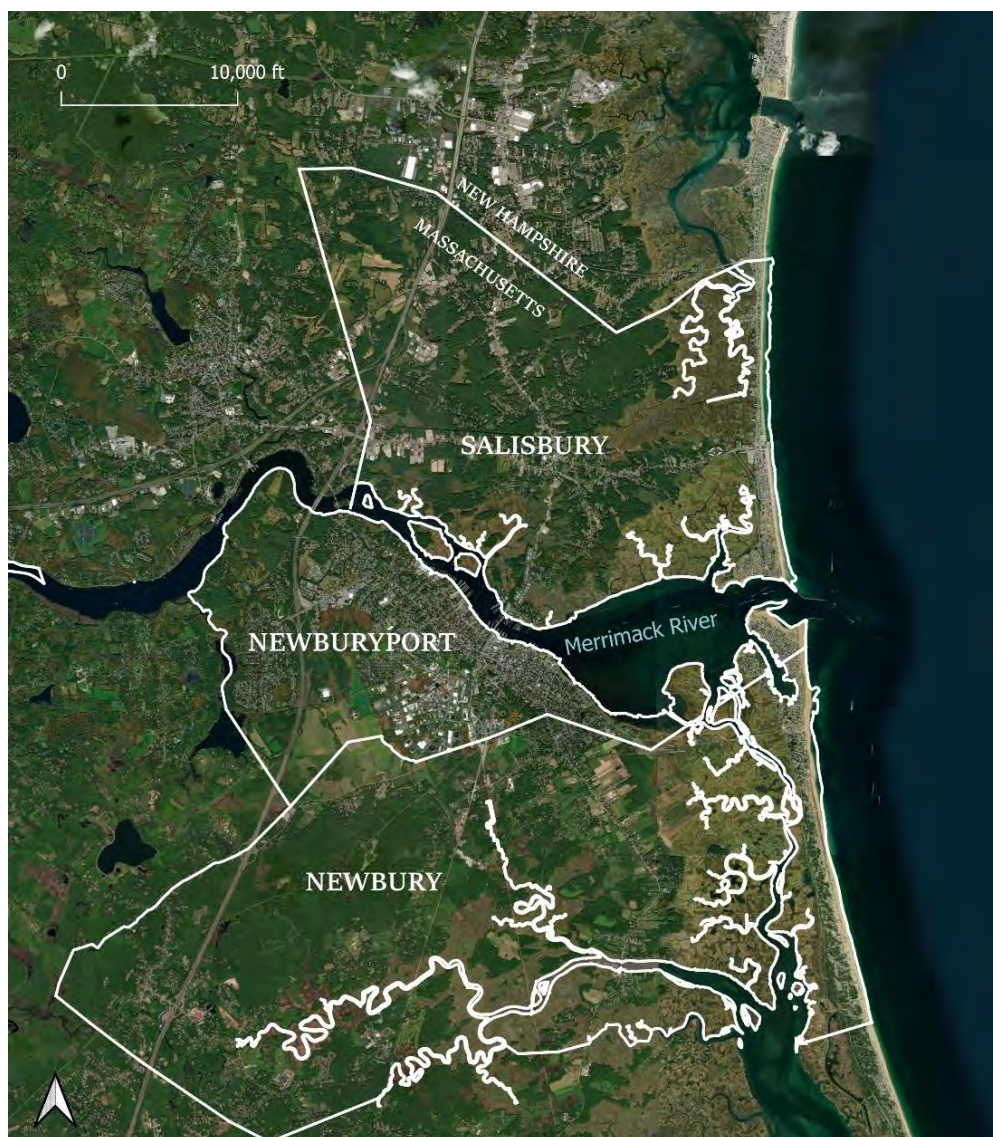
Figure 1.1. The three communities represented in the Upper North Shore Regional Sediment Study: Salisbury, Newburyport, and Newbury.

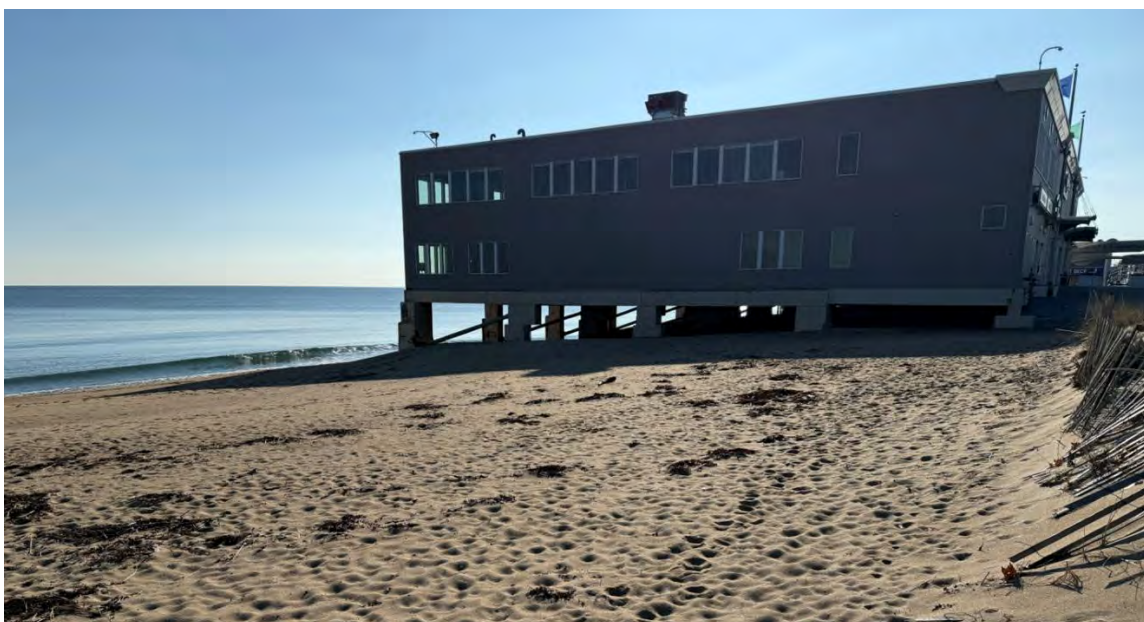
Figure 1.3. The Pavillion on stilts above the beach. Salisbury, MA.

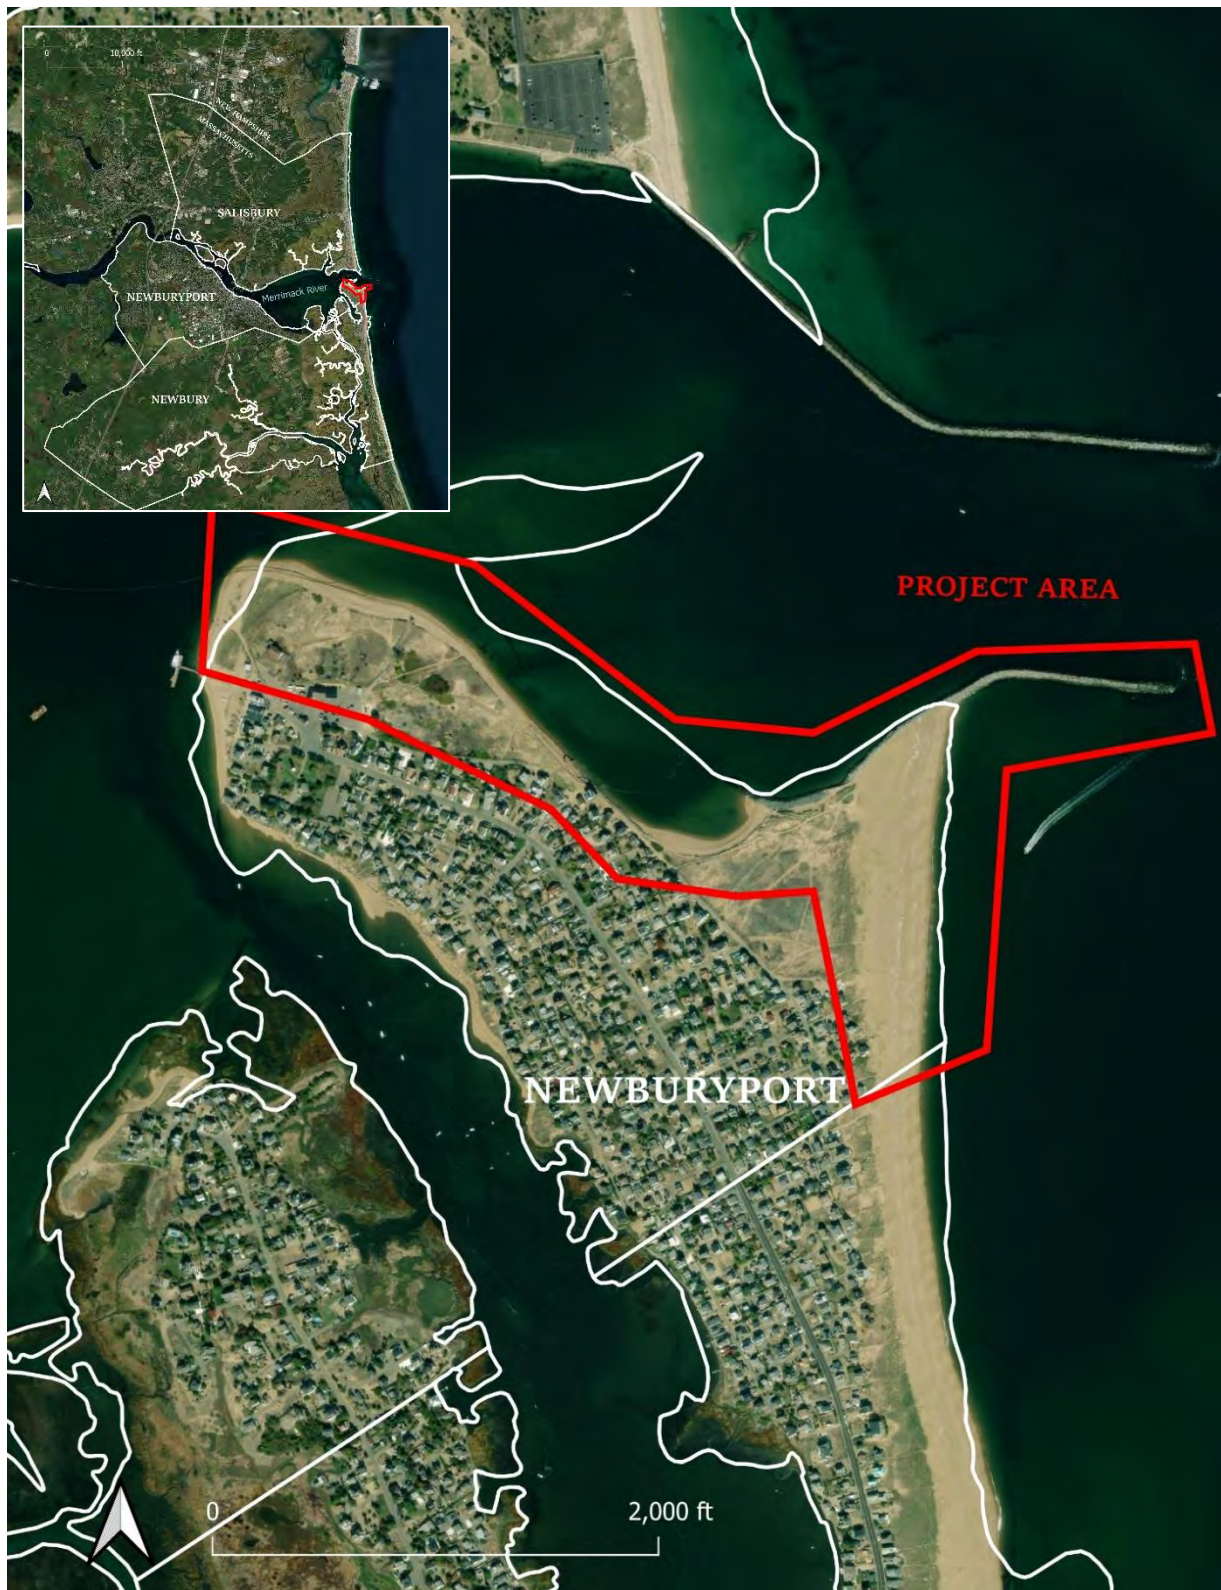
Figure 1.5. Study boundary for the Town of Newburyport. Reservation Terrace sits within the inlet and the stretch below the southern jetty is considered part of Plum Island Beach.

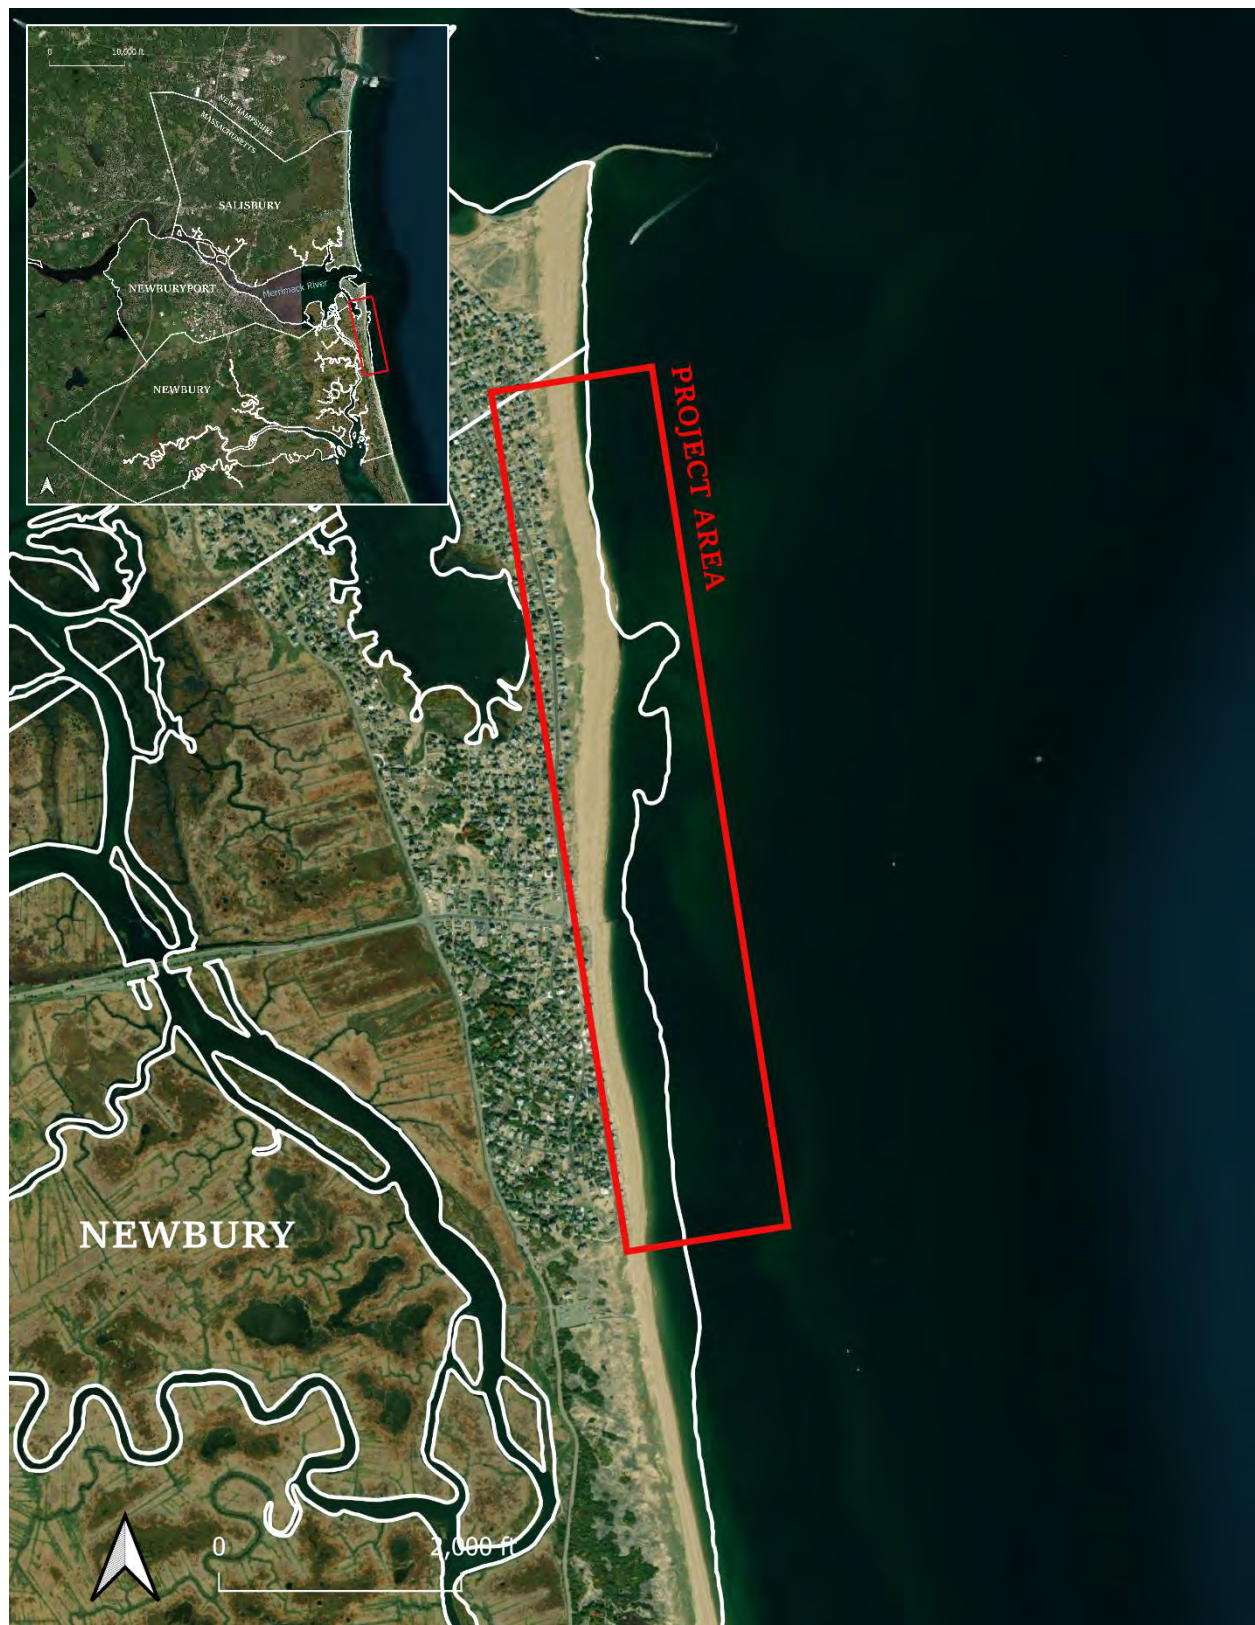
Figure 1.6. Study boundary for the Town of Newbury. Plum Island Beach was considered to the end of the residential area and beginning of the federally owned beachfront.

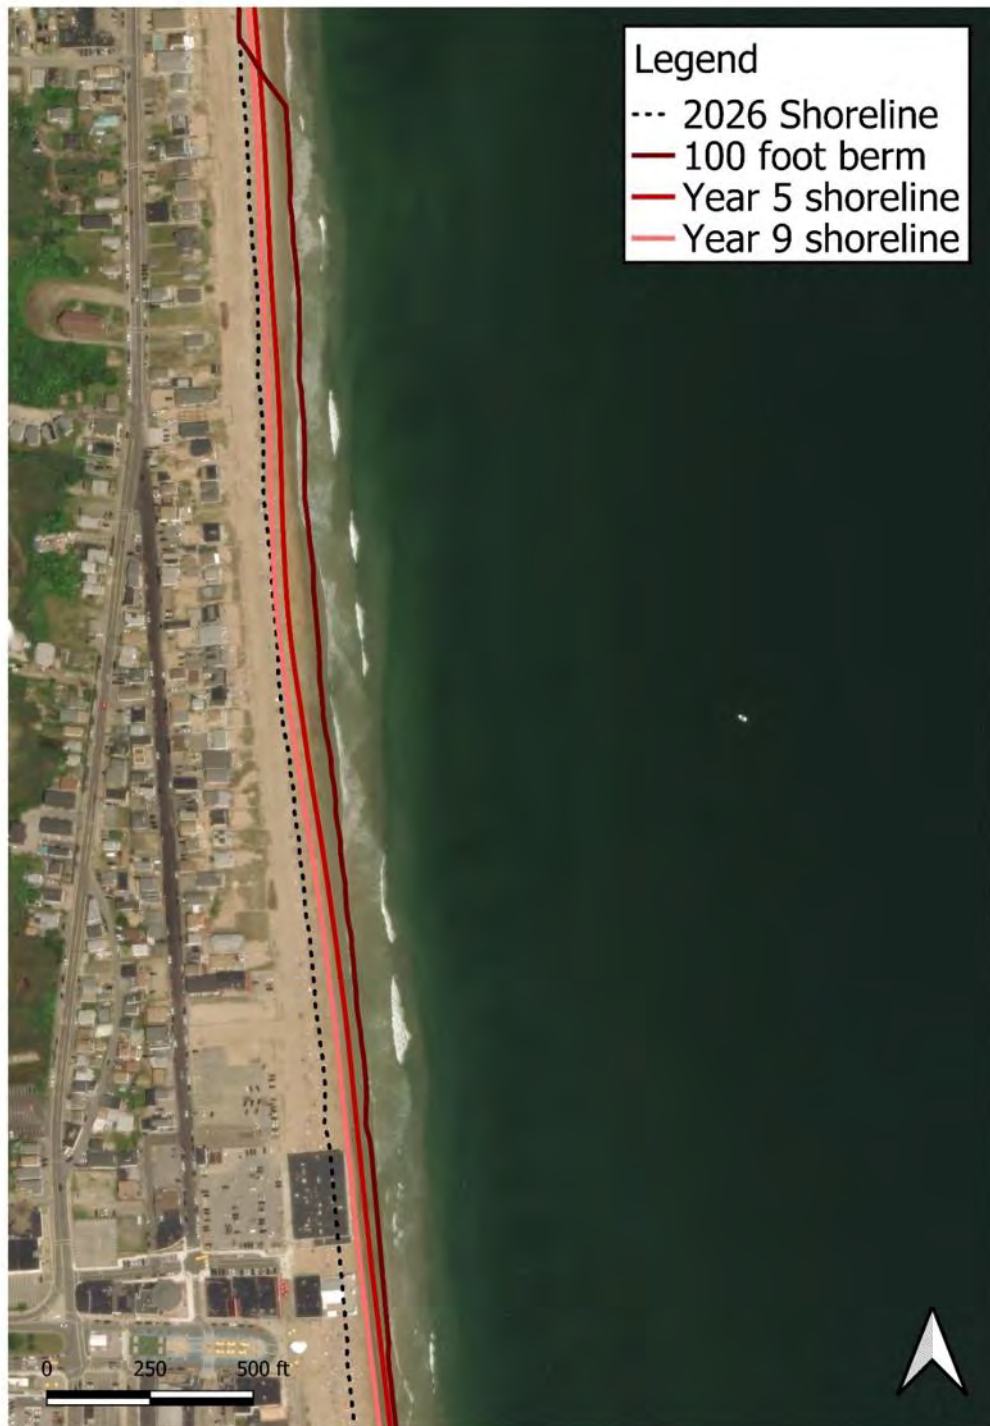
Figure 1.7. A close up of Scenario 4 immediately after 100-foot berm construction (dark red), as well as modeled shorelines 5 and 9 years (red and pink, respectively) after placement. The 2026 shoreline is shown (dashed black).

For Salisbury Beach, a large-scale nourishment project is suggested to address the net erosion of the shoreline as well as low-lying dune elevations. A large-scale nourishment project would extend both the seaward portion of the shoreline as well as increase the overall elevation of the beach, providing increased protection to adjacent coastal infrastructure. In recent years, the Plum Island shoreline has been accreting, due to both the location of the bypass bar as well as the repair of the southern Merrimack River inlet jetty, which cuts off the sediment supply to Reservation Terrace. Nourishment alternatives for Plum Island were generated in the case of a future erosion hot spot. The erosion hot spot would be identified through monitoring of the shoreline, and ideally preventative nourishment would be implemented, before significant erosion impacts adjacent coastal infrastructure. Modeled nourishment scenarios for Salisbury Beach and Plum Island are shown in Figures 1.7 and 1.8, respectively.

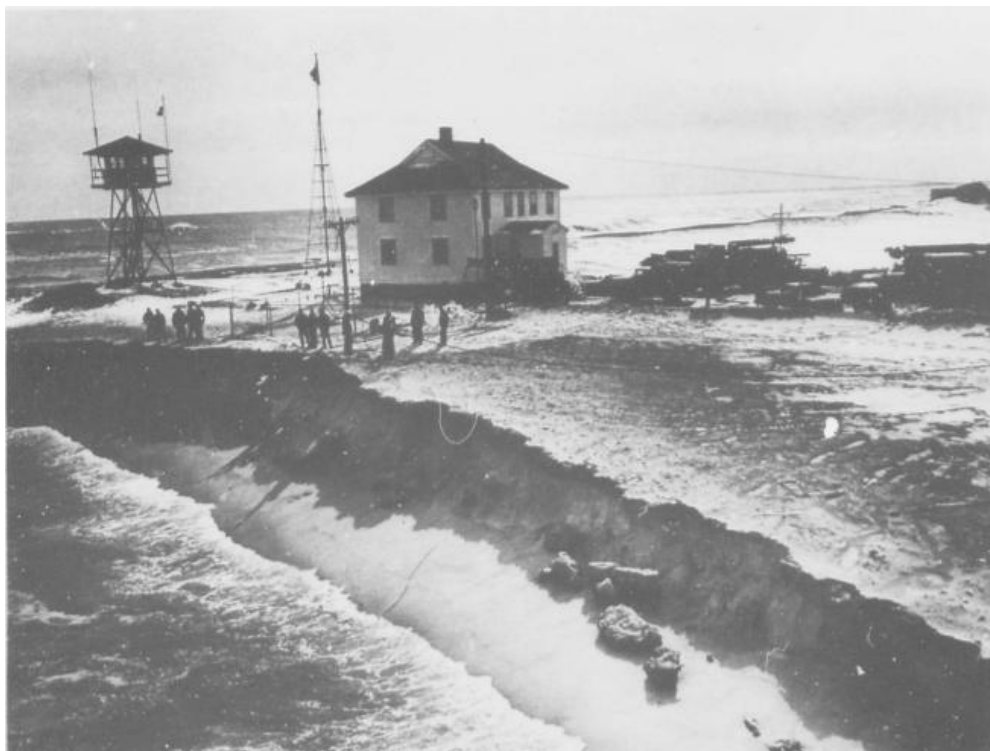
Figure 2.4. Shear erosion from February winter storm of 1969, when the Coast Guard building still sat near the jetty. Reservation Terrace, MA (photo from Boston Globe).

Since jetty management began in 1881, the inlet entrance has been generally stable. For the shorelines along Plum Island, significant change has occurred. While the normal patterns of wave refraction would occur without the jetties, the jetties have been found to cause increased erosion on Plum Island due to restriction of inlet drift. The changes brought about by engineering intervention have had observable effects on the Reservation Terrace area since even 1969. In February of 1969, three major storms entered the area, affecting about 18 high tides and removing over one-million cubic yards of sand, as well as up to 200 feet of property loss (Figure 2.4) (Hubbard 1975; Jones and Cameron 1976).

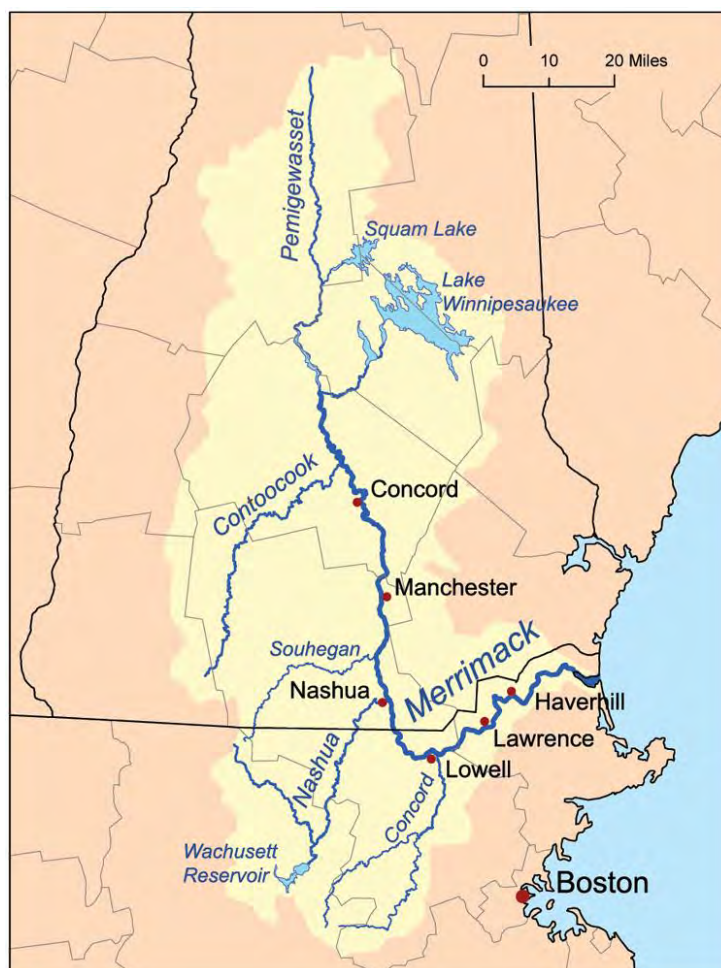
Figure 2.5. Merrimack River watershed extent. (American Rivers, n.d.)

The Merrimack River Valley Watershed is the 4<sup>th</sup> largest in New England. Over 200 New Hampshire and Massachusetts communities are situated along the river, supplying drinking water for over 600,000 people and serving as a source of recreation, sustenance, and livelihoods for thousands of people. There are five smaller rivers draining into the Merrimack: Pemigewasset (NH), Contoocook (NH), Souhegan (NH/MA), Nashua (NH/MA), and Concord (MA) rivers. The Merrimack also has connection to the Squam Lake, Lake Winnepesaukee, and the Wachusett Reservoir (Figure 2.5).

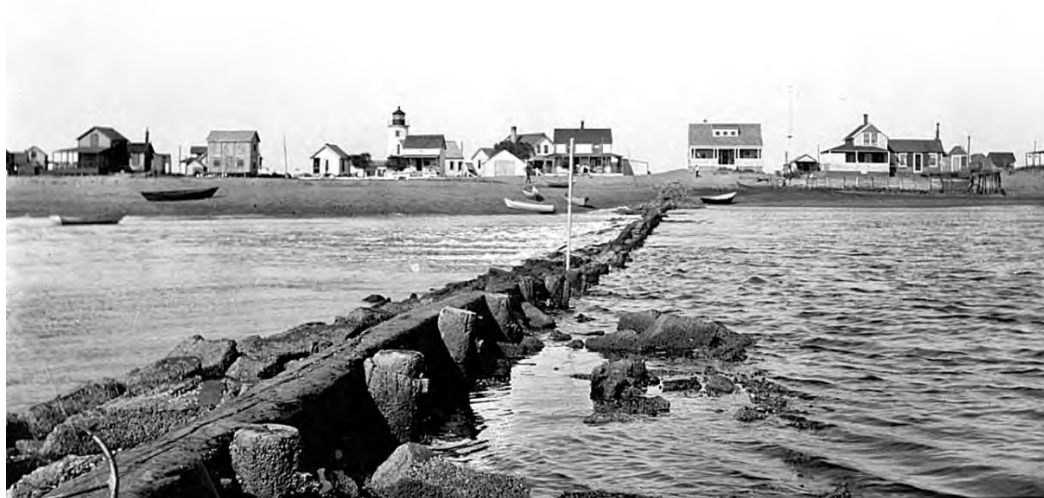
Figure 2.6. Dike crossing the “basin” inside the jetty in 1905 (Friends of Plum Island Light, n.d.).

The central hard engineering structures are the two Merrimack River jetties. The north jetty is connected to Salisbury Beach and extends eastward approximately 4,118 feet, while the southern jetty is connected to the Plum Island Point and Reservation Terrace area and extends about 2,445 feet (Bourne Consulting Engineering, 2015). The jetties have long been maintained under the Army Corp of Engineers, who began its construction in 1881. Prior to the jetty creation, the area underwent construction of dikes and removal of several large boulder fields further down the river (Figure 2.6).

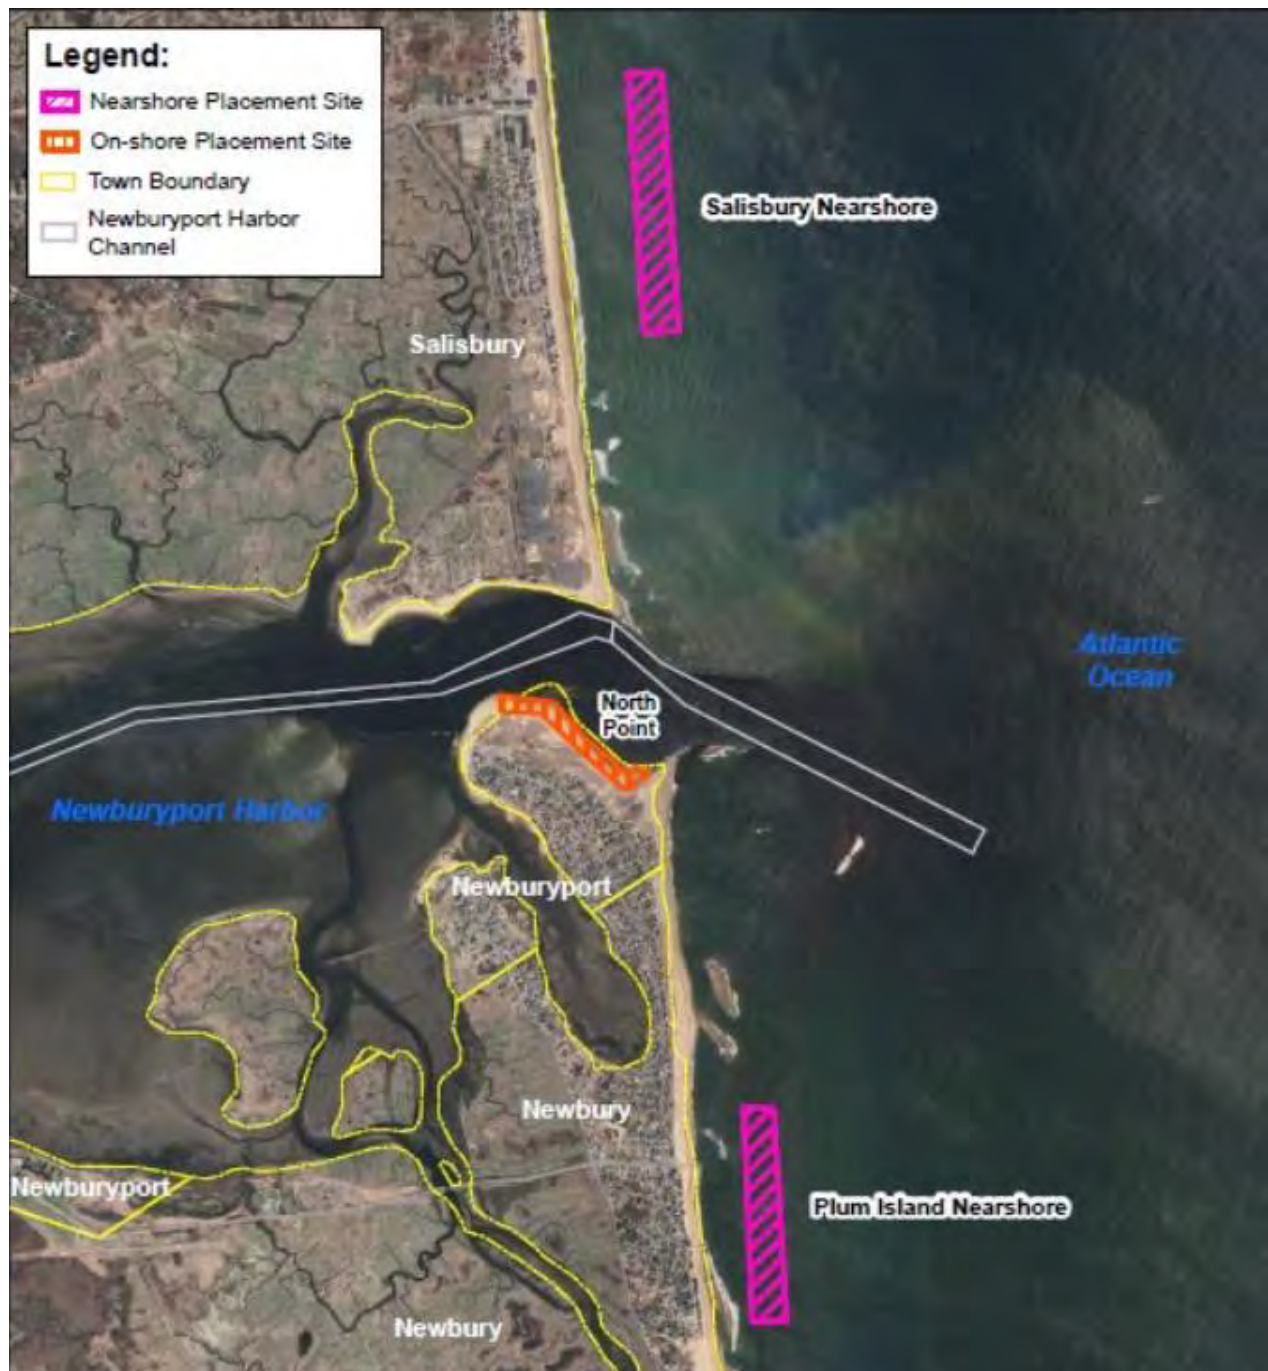
Figure 2.8. Nearshore and on-shore placement sites proposed in 2021 by the USACE (United States Army Corps of Engineers, 2021).

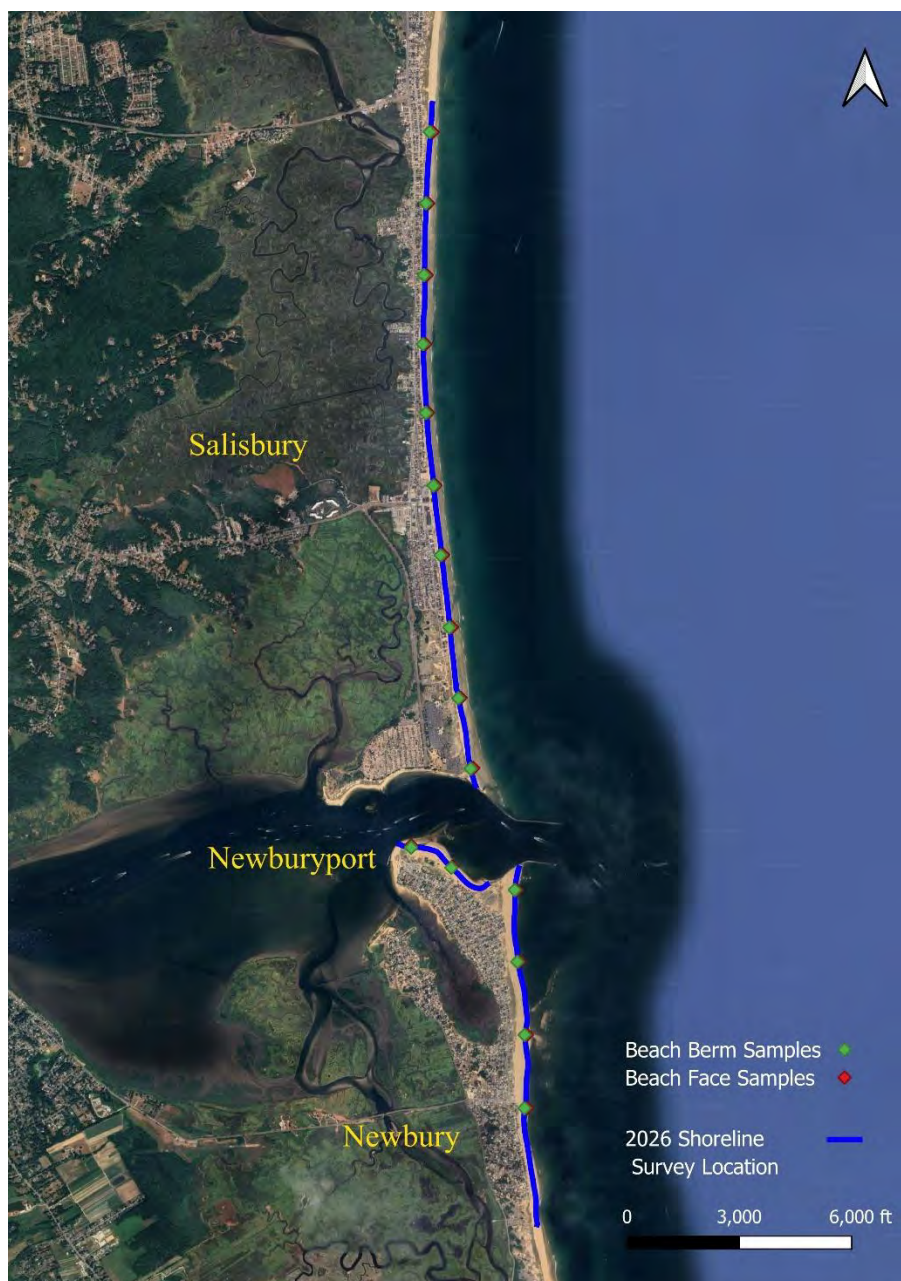
Figure 3.3. Sediment grab sample locations, both beach berm (green) and face (red), overlaid on the 2026 shoreline survey location.

Grain size sampling was also completed along the project shoreline. Two samples were taken approximately every 2000 feet. Sixteen sampling transects were identified, resulting in a total of 32 samples, where one sample was collected on the beach face and one sample was collected on the beach berm along each transect (Figure 3.3).

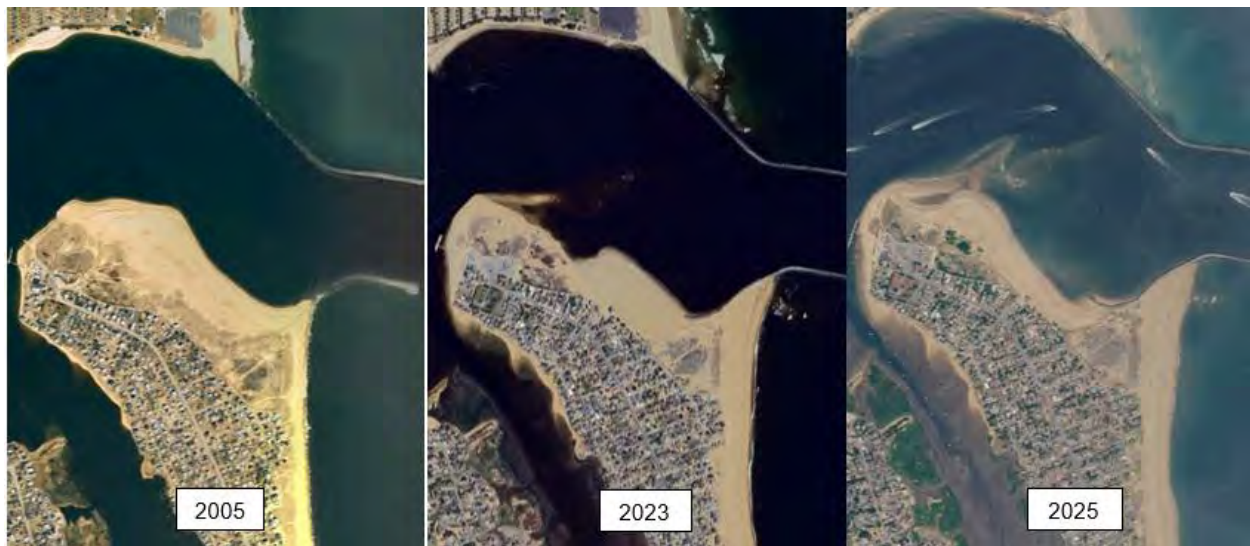
Figure 3.7. Aerial imagery of Reservation Terrace during period of relative stability (2005), following emergency nourishment project (2023), and shortly after nourishment project (2025).

Evident from aerial imagery (Figure 3.7), Reservation Terrace has lost a significant amount of sediment since the 2023 nourishment. To update predictions about the lifespan of beach nourishment projects in these areas, an estimate of the volume loss was conducted.

A geometric method was used to approximate erosion since beach nourishment unnaturally changed the topobathy of the shoreline, meaning that the characteristic profile method was not applicable. The original USACE plans were overlaid on the site and shoreline marked. An approximate surface area of fill was used to determine an average depth of nourishment, via the use of recorded nourishment value, 220,000 CY. By moving the shoreline inward to the 2026 position, and maintaining the slopes of the placed nourishment as an assumption, it was estimated that about 86% percent or approximately 190,000 CY of the original nourishment had been lost. This estimate does not take into account the potential for sediment to equilibrate into the profile further offshore, however, due to the observed gyre effect in Reservation Terrace, it is reasonable that much of this nourishment was transported out of the inlet. Additionally, this estimate does not account of spreading along the beach, as seen by visual accumulation of sand on the western end of Reservation Terrace in Figure 3.7. Thus, it is likely that this estimate is on the high end and is more indicative of how much the sand has shifted out of its original location since the placement in 2023.

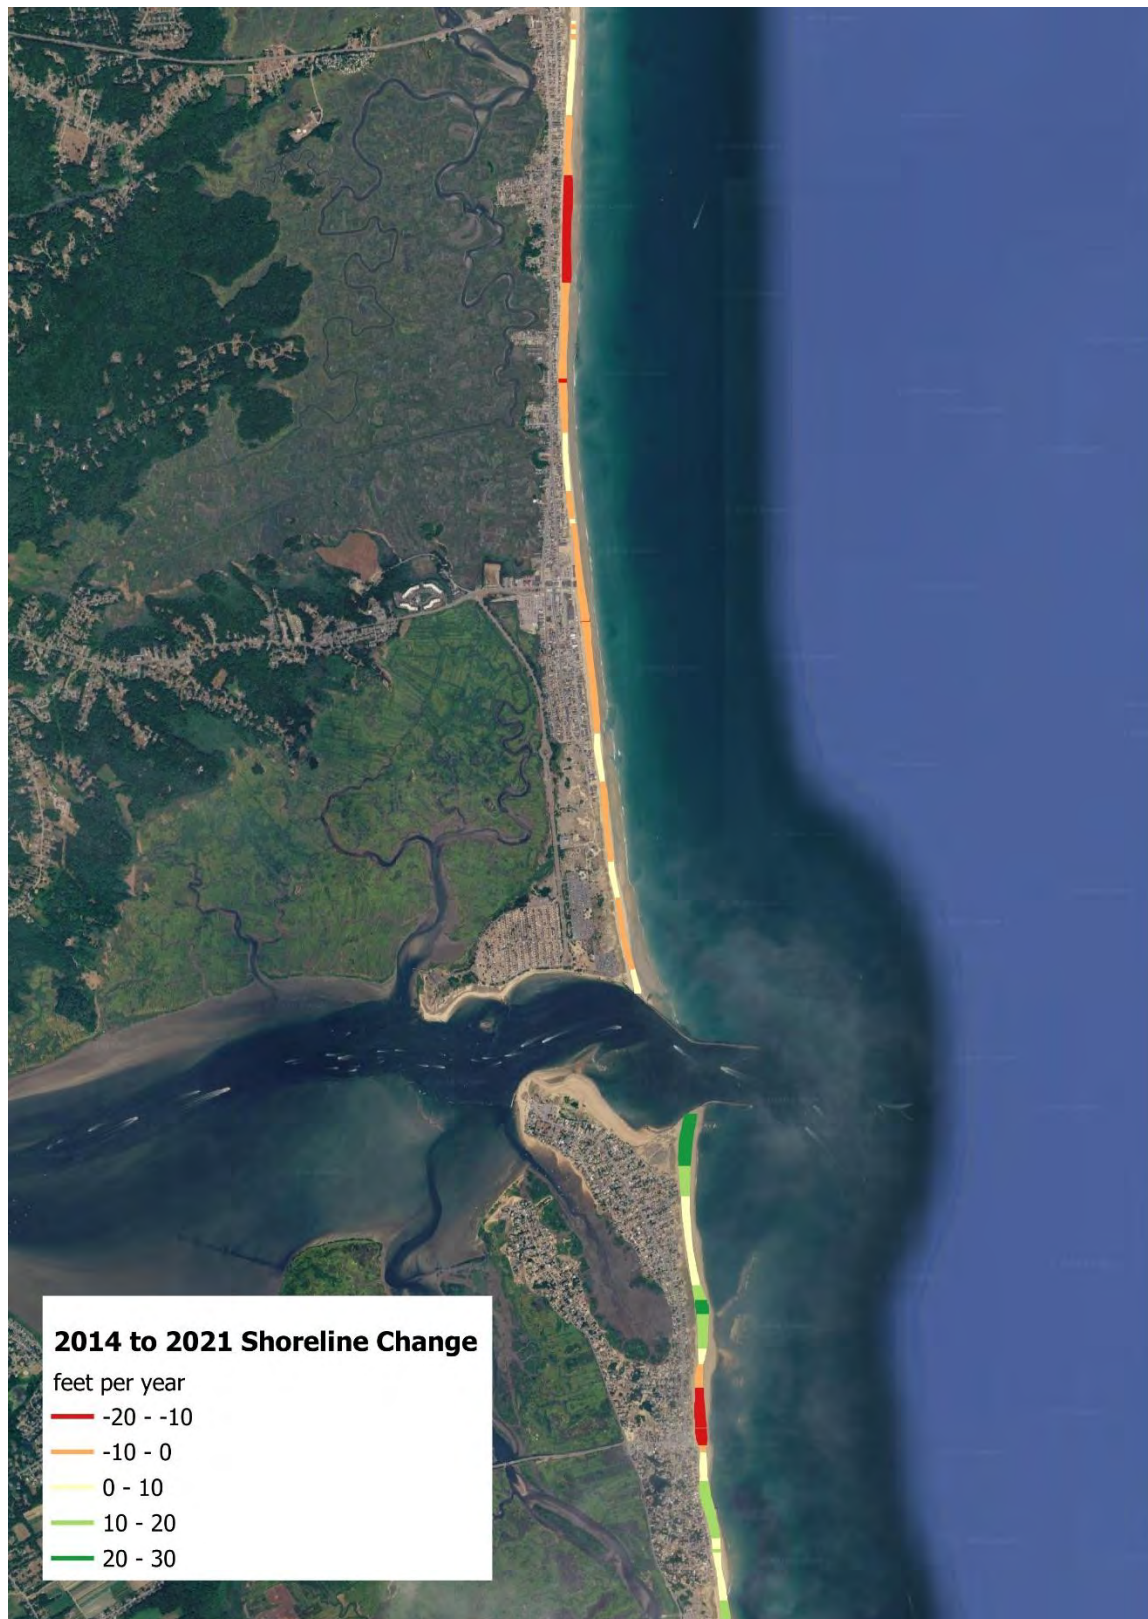
Figure 4.9. Shoreline change along Salisbury Beach and Plum Island between 2014 and 2021.

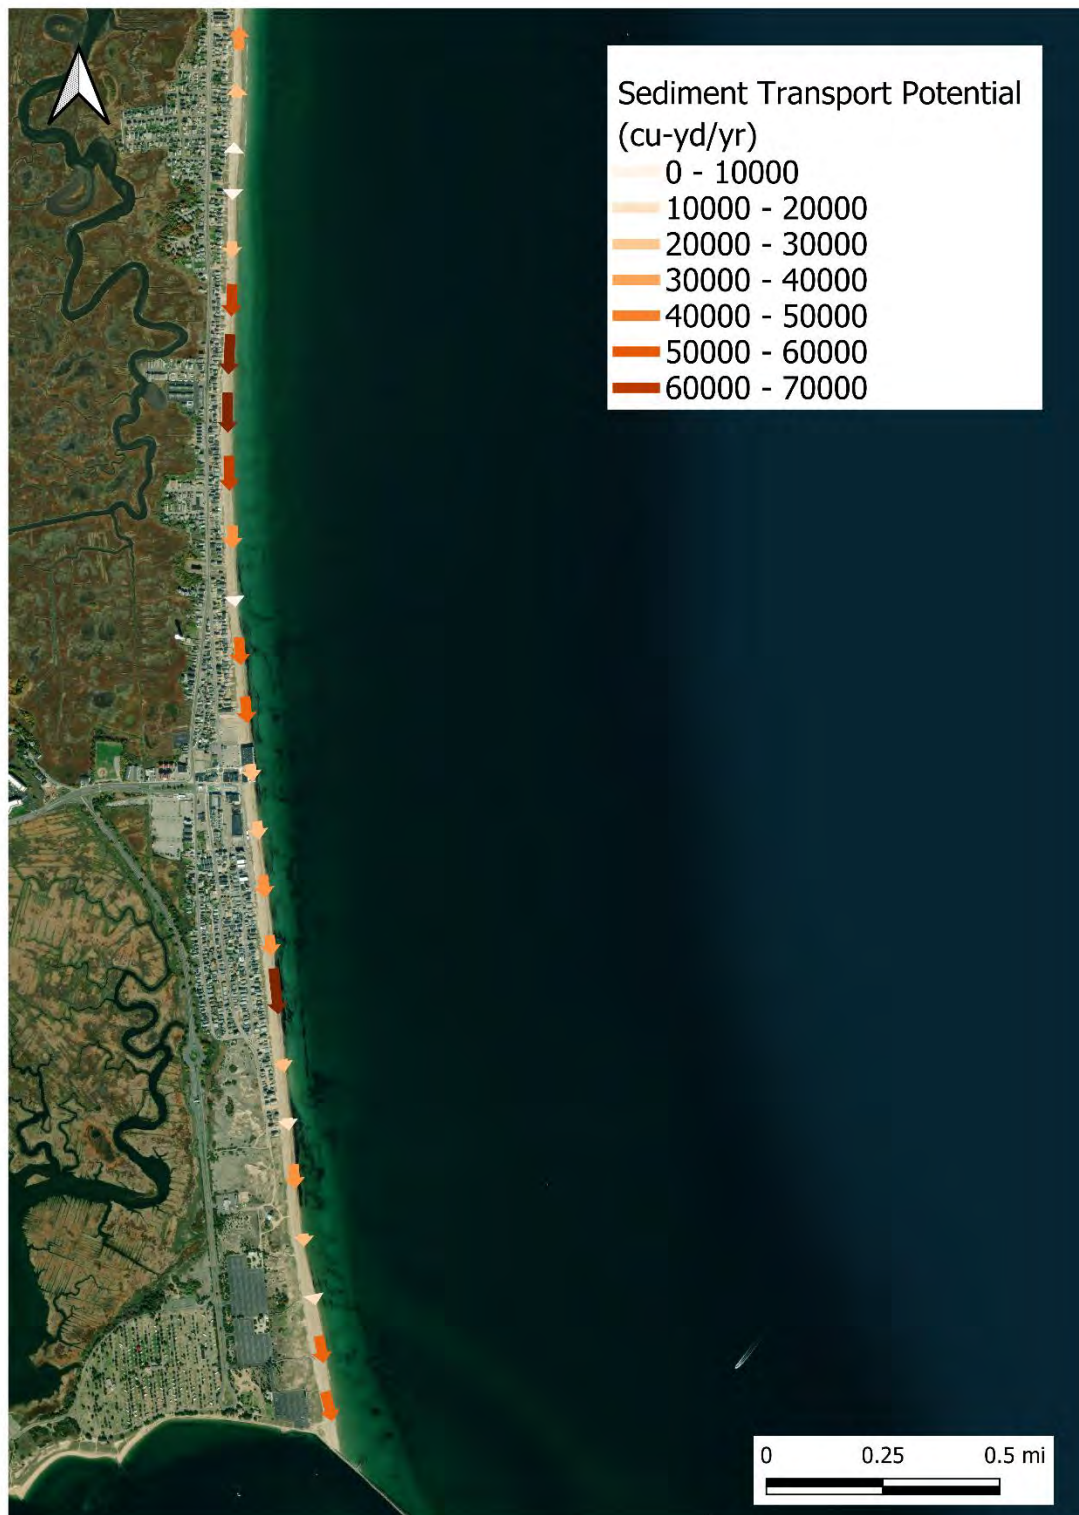
Figure 4.10. Computed net annual sediment transport potential rates along the Salisbury Beach shoreline. Arrows indicate the direction of transport, while the color and size of the arrows indicate transport magnitude.

The shorelines on either side of the inlet were modeled independently of each other using wave output from their respective grids, with Figure 4.10 and 4.11 showing transport potential for Salisbury and Plum Island respectively. Sediment transport potential for Salisbury was calculated from the MA-NH border in the north to the Merrimack River inlet jetty in the south, about a 3.4-mile segment. Sediment transport potential for Plum Island was calculated from the Merrimack River inlet jetty in the north to the end of the populated region of Plum Island in the south, about a 1.8-mile segment.

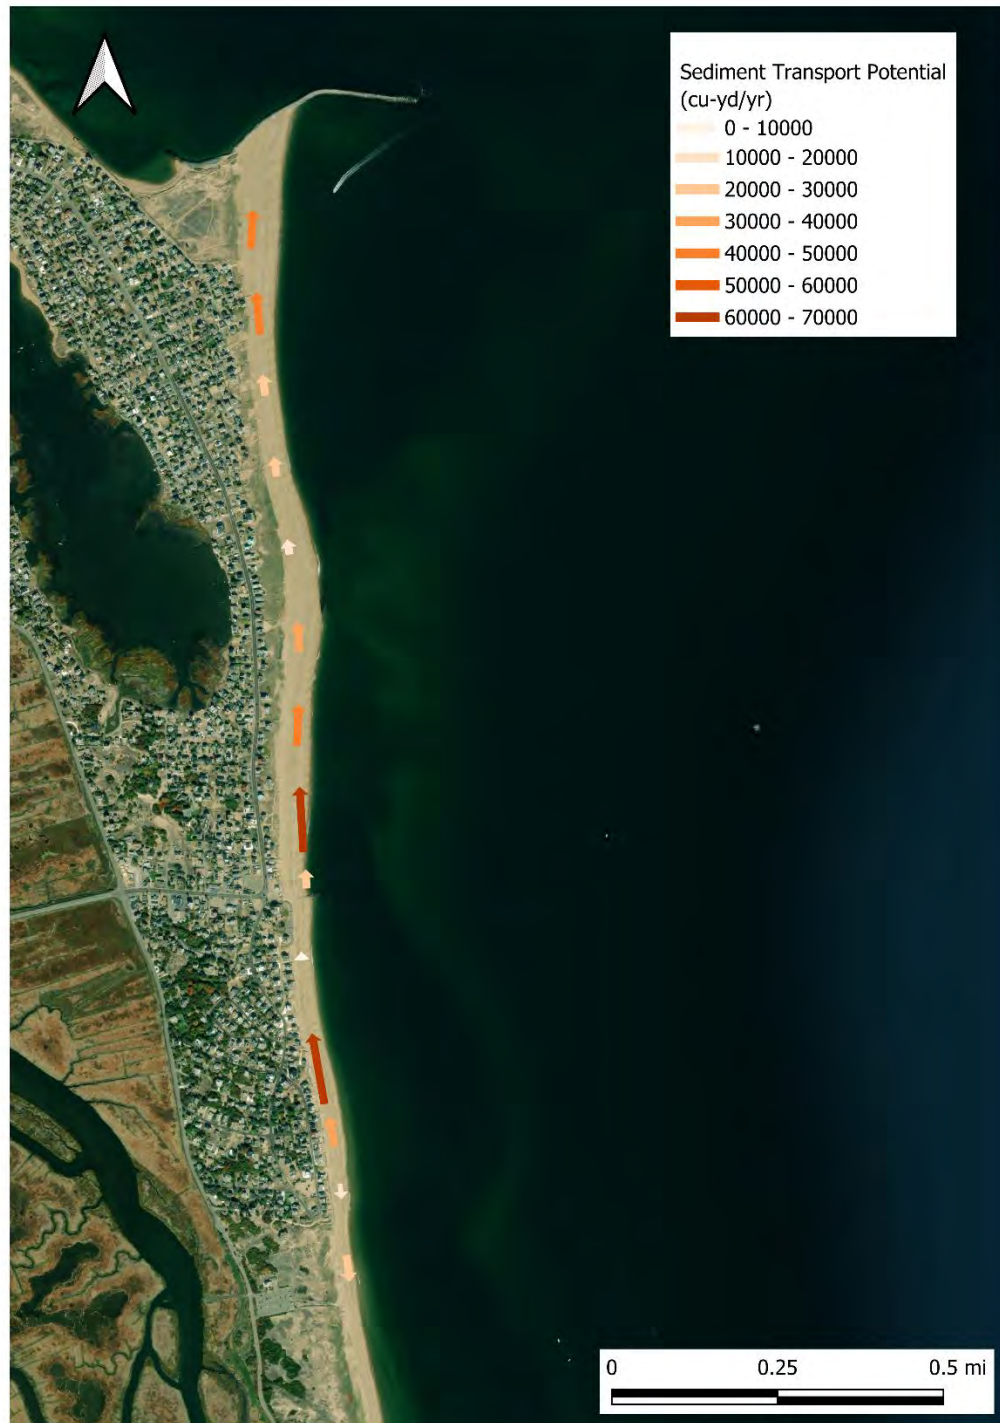
Figure 4.11. Computed net annual sediment transport potential rates along Plum Island Beach shoreline. Arrows indicate the direction of transport, while the color and size of the arrows indicate transport magnitude.

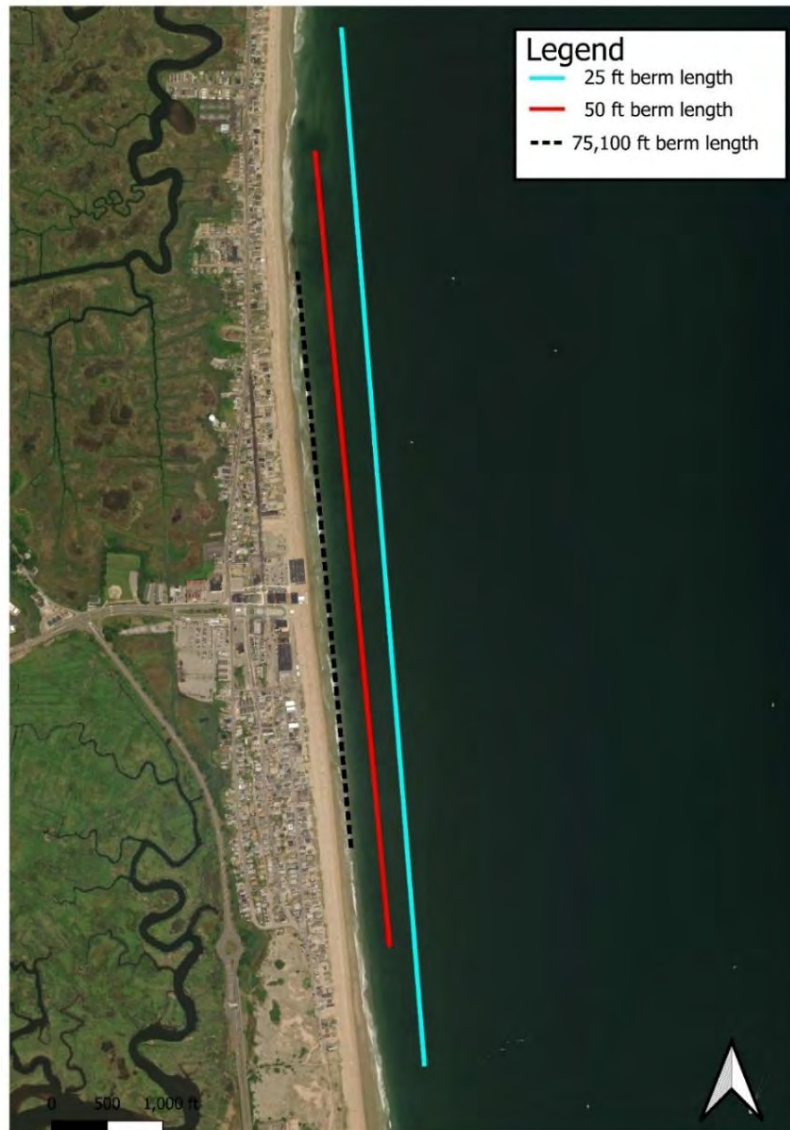
Figure 5.2. Approximate extents of nourishment scenarios for Salisbury Beach detailed in Table 5.1.

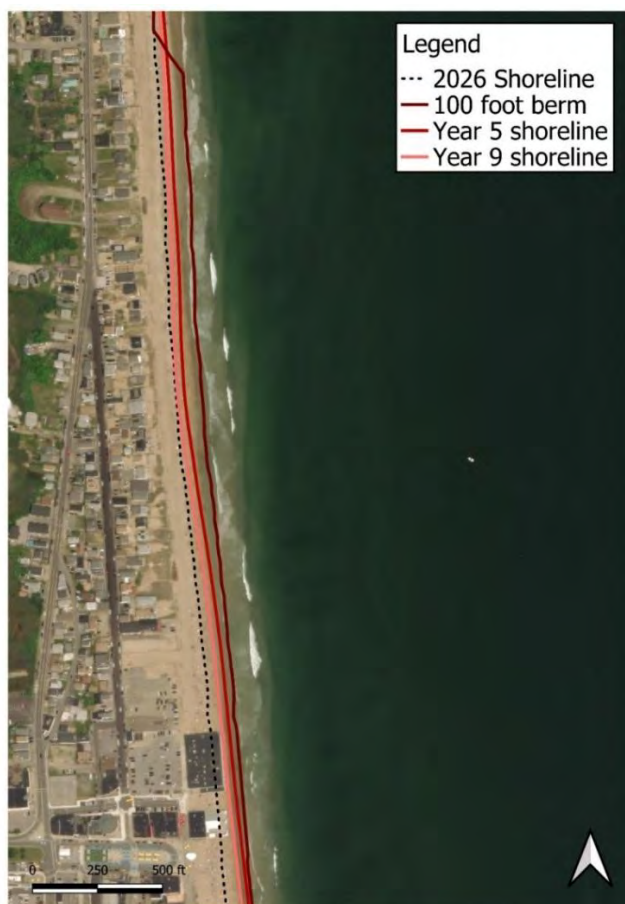
Figure 5.4. A close up of Scenario 4 immediately after 100-foot berm construction (dark red), as well as modeled shorelines 5 and 9 years (red and pink, respectively) after placement. The 2026 shoreline is shown (dashed black).

After the nourishment is placed, the cross-shore nourishment profile will equilibrate to more closely match the beach profile before fill is constructed. Natural forces will act on the sediment to generate longshore movement. A visual of the cross-shore beach profile 1 year after construction (as well as selected later years) for each nourishment scenario is shown in Figure 5.5. The profiles represent the mean shoreline position over time, as some areas along the fill template will have eroded more or less than what is shown. Since erosion along the fill metric is not uniform, monitoring for the emergence of erosion hot spots along the fill template is necessary. Such erosion hot spots could emerge due to minor or moderate hot spots, and may necessitate a smaller scale nourishment project.

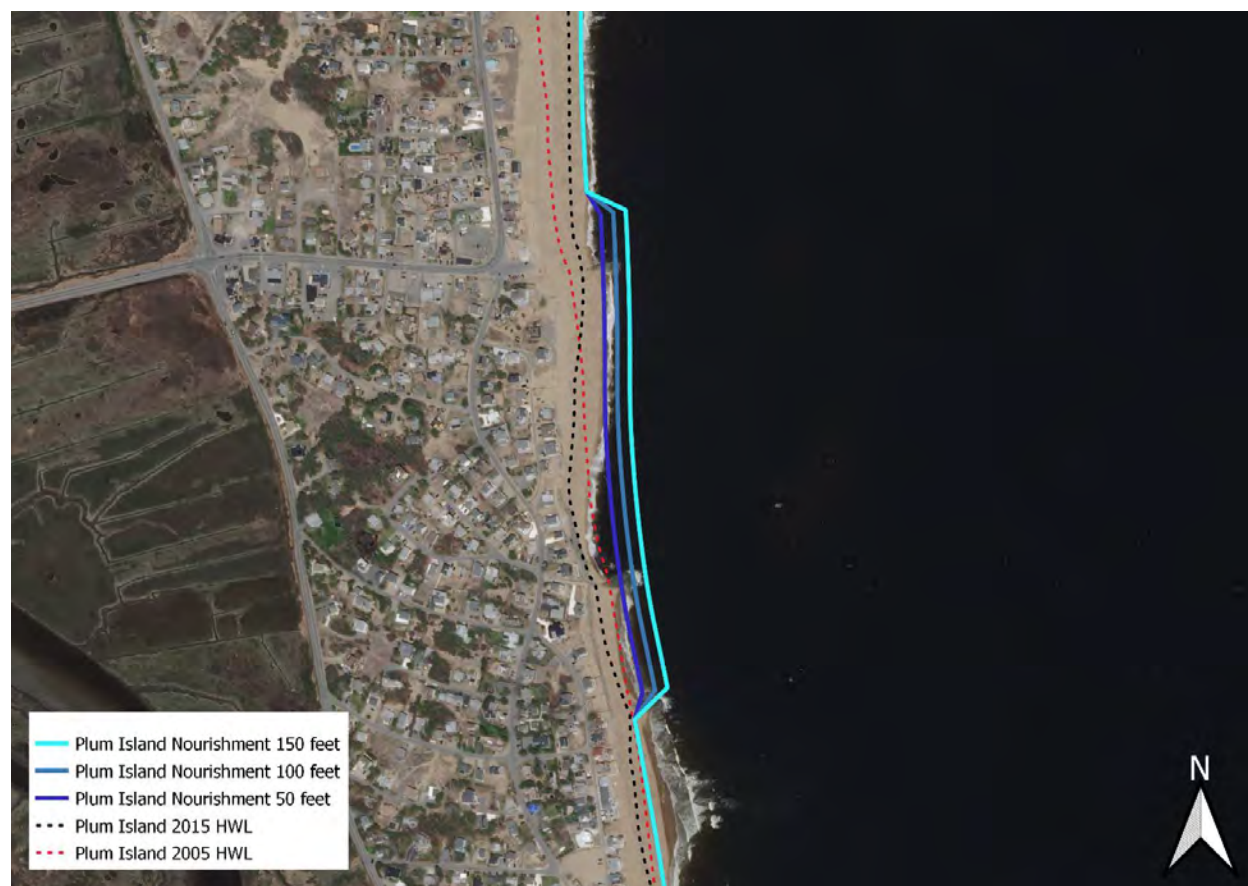
Figure 5.6. Plum Island nourishment scenarios for the early 2010s erosion hot spot from Figure 5.17 in Applied Coastal Research and Engineering, 2021.

Since the presence of an erosion hot spot along Plum Island is highly dependent on the location of the bypass bar, Sustainable Coastal Solutions suggests monitoring of the bypass bar location and shoreline to assess potential development of an erosion hot spot. Nourishment scenarios can be designed based on the emergence of the erosion hot spot and ideally implemented before it becomes detrimental to infrastructure. The previous sediment study developed three nourishment scenarios: 50-, 100-, and 150-foot berms that each span the same 2,000 feet of the erosion hot spot (Figure 5.6) (Applied Coastal Research and Engineering, 2021). The specifications and design life of each scenario is included in Table 5.2.
